The January 17, 1994, Northridge Earthquake, California

H. S. Lew¹, Jim Cooper², Sam Hacopian³, Walter Hays⁴, and Mike Mahoney⁵

ABSTRACT

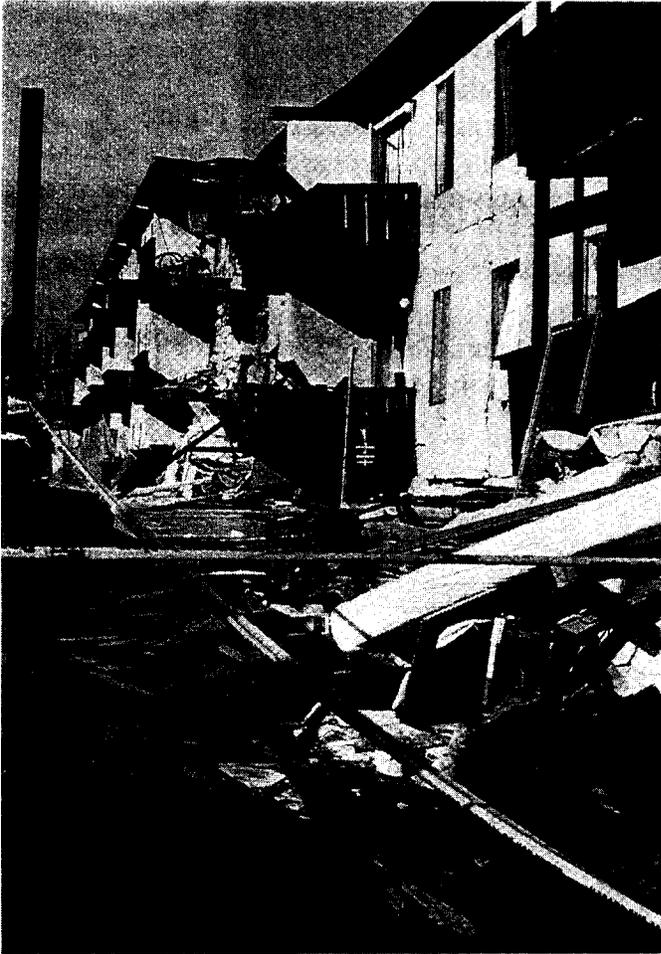
collapsed. The first story gave way while the second and third stories remained largely intact. The sixteen people killed were in the first story apartments. All the buildings in the complex suffered some damage (Figure 5).

Figure 5 At the Northridge Meadows apartment complex near the epicenter the first story in several of the buildings collapsed, killing sixteen people. The second and third stories remained essentially intact. Large portions of the first story in these buildings were open space for parking. This type of collapse occurred in a significant number of similar apartment buildings throughout the affected area.

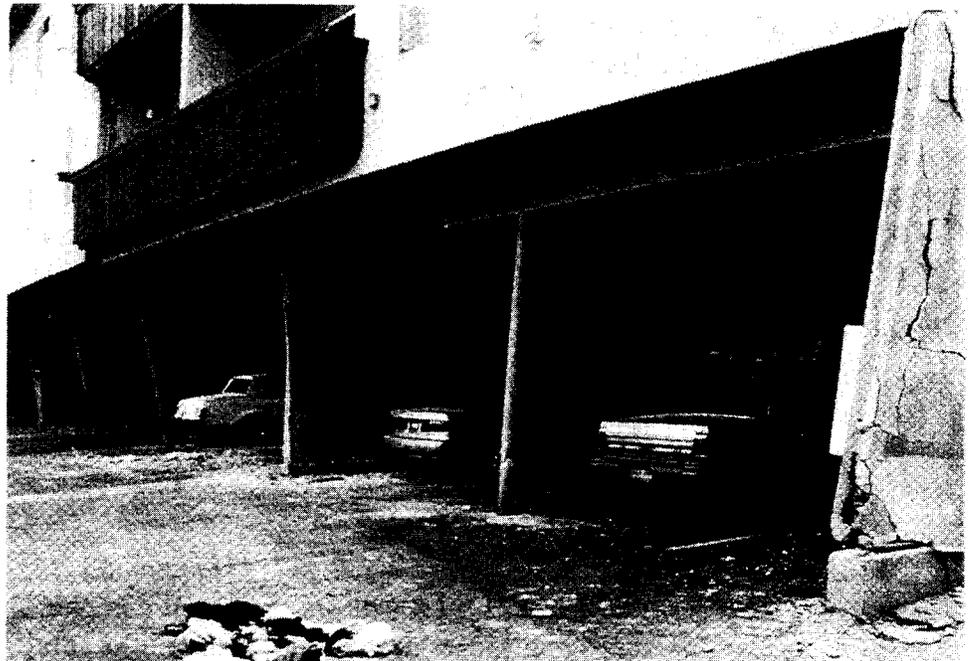
Figure 6 Steel pipe columns between parking bays supported the upper stories of the Northridge Meadows apartment buildings. Few of the buildings in the north half of the complex collapsed, but all were damaged.

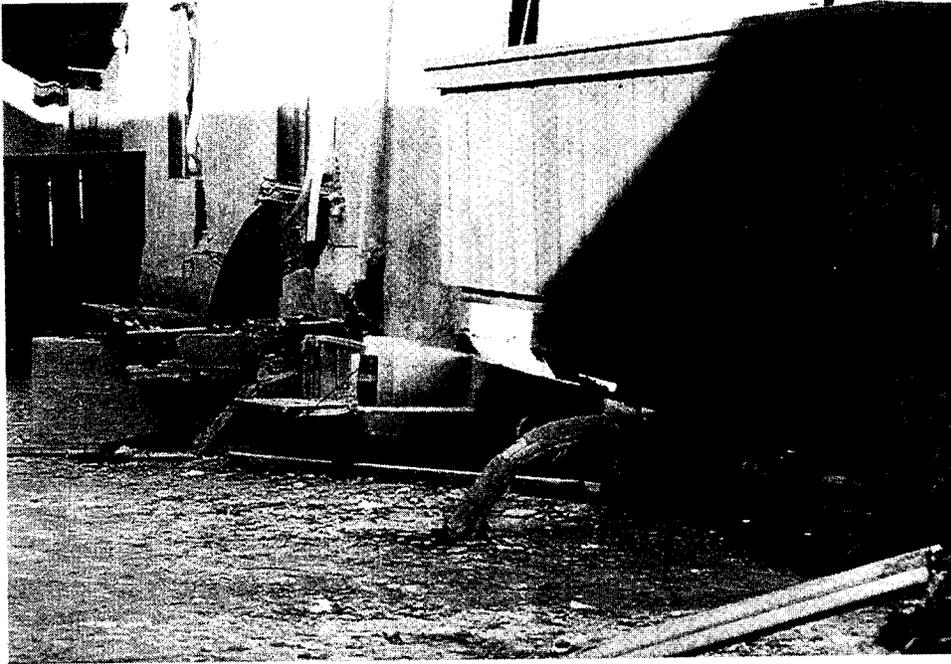
The upper stories of the collapsed buildings were displaced laterally and in some cases came to rest offset by as much as three meters from their original locations. The steel pipe columns, which hinged at their bases, apparently controlled the distance of the offset as they bent to the ground (Figure 7). The Northridge Meadows building configuration, two stories of living space in a long, narrow building above one level of parking, is common in the San Fernando Valley. Many buildings of this type sustained serious damage, and some collapsed. These buildings were also built in the late 1960's or early 1970's, when use of stucco for seismic resistance in low-rise buildings was common. Current codes have essentially ban the use of this material.

Figure 7 At Northridge Meadows, the first story steel pipe columns generally hinged near their bases but retained their length, controlling the displacement of the upper stories.

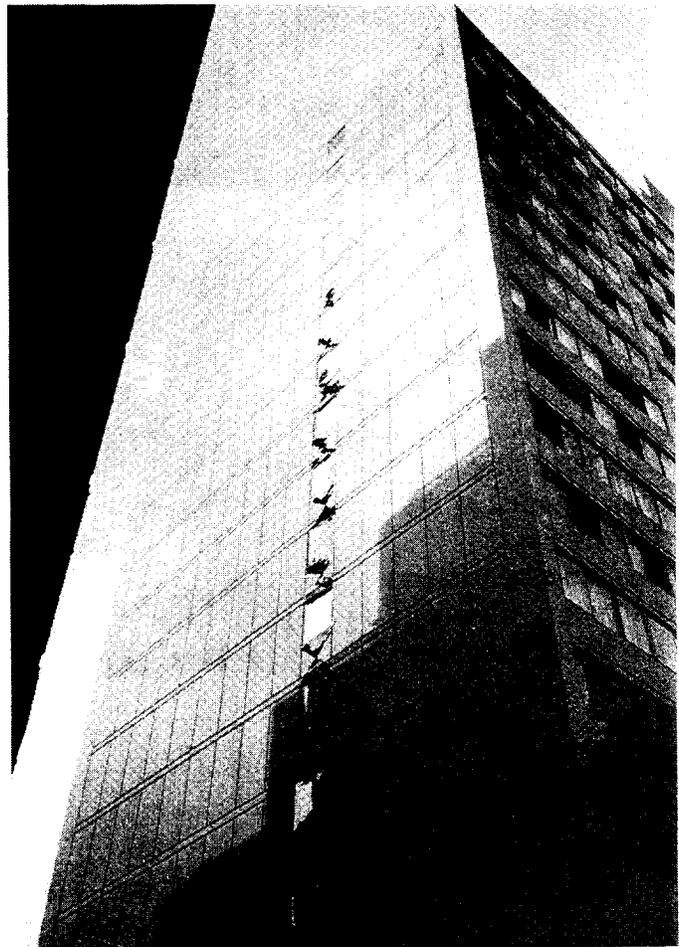
The transverse end walls are pierced by a single vertical row of window openings. The wall segments between the windows act as coupling beams linking the wall segments on either side. These beams suffered serious diagonal cracking (Figure 8). In the longitudinal direction, the lateral-force resistance is provided by concrete moment frames. The front of the building shows

Figure 8 Champagne Towers apartment building in Santa Monica suffered a classic form of earthquake damage: shear failure of the coupling beams between linked shear walls at the transverse end of the building.

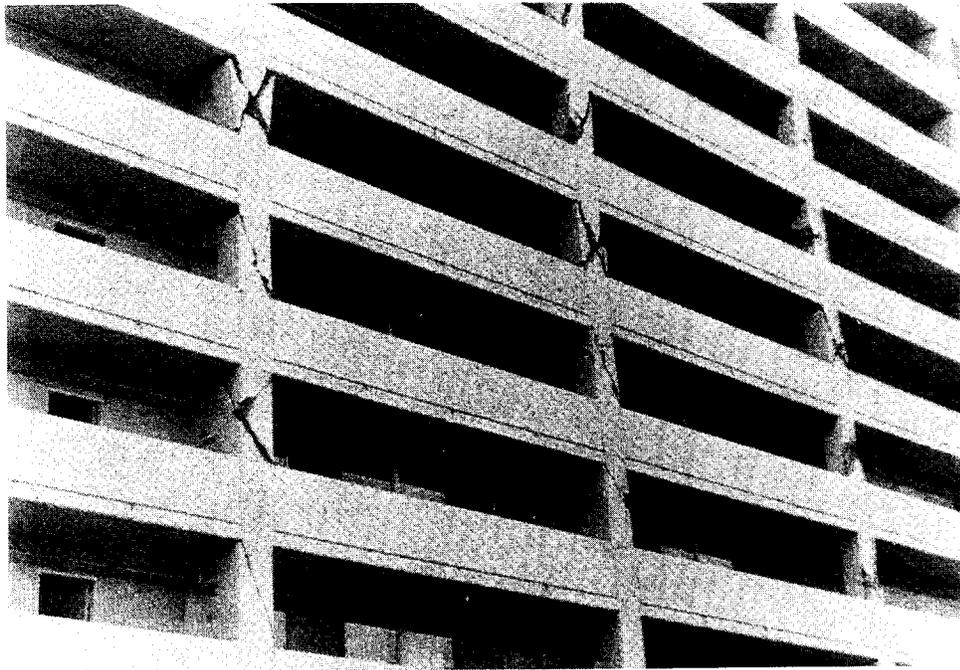
no sign of damage. At the back, the columns and transverse wall ends are diagonally cracked (Figure 9). The solid infill railings which rise to about mid-height of the columns create an unintentional "short-column" effect, causing the columns to fail in shear. At the front of the building, metal pipe railings are provided at the balconies rather than solid infill, as at the back. This may partially explain why there is no apparent damage at the front of the building.

Figure 9 The back of the Champagne Towers building was badly damaged. The railings here are solid infill, which effectively stiffen the lower half of the columns. The shortened upper half of the columns were forced to accommodate all the displacement, and they failed in shear.

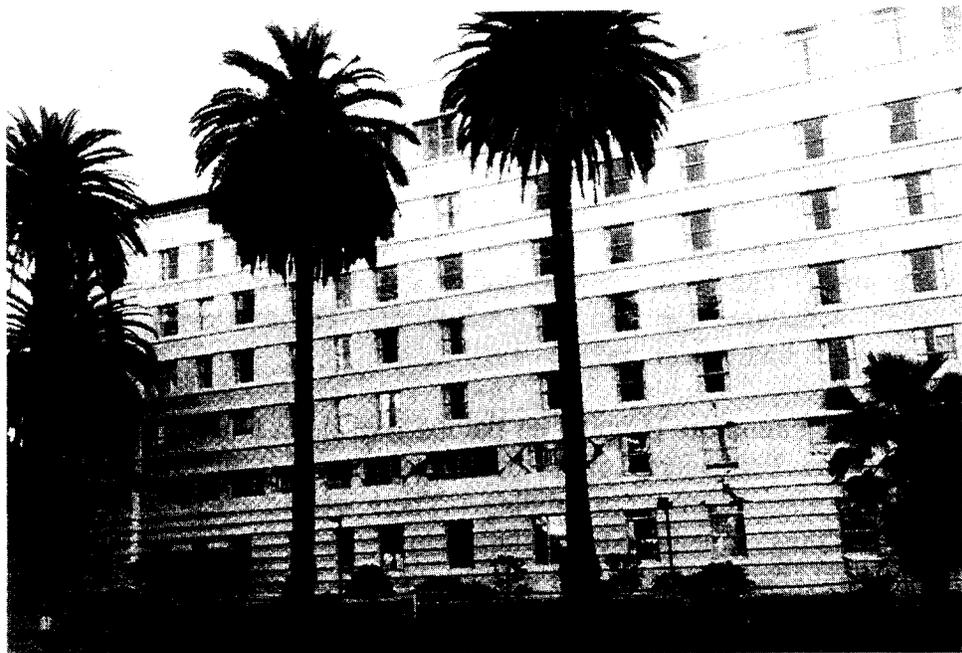
The original hospitals of Holy Cross and Olive View were badly damaged in the 1971 San Fernando earthquake. They were rebuilt following the requirements of the Hospital Act introduced by the State of California after the 1971 quake. The structural systems of these two hospitals performed well in the Northridge earthquake. However, damage to the sprinkler and chilled water systems at Olive View rendered the building temporarily unusable. At Holy Cross, damage to the air handling system forced closure of the hospital. However, St. John's Hospital in Santa Monica was closed due to structural damage. The 7-story northwest wing, which was built in 1952, had severe diagonal cracks in the piers between windows (Figure 10).

Figure 10 The seven-story northwest wing of St. John's hospital in Santa Monica experienced severe X-cracking in the piers between the second story windows.

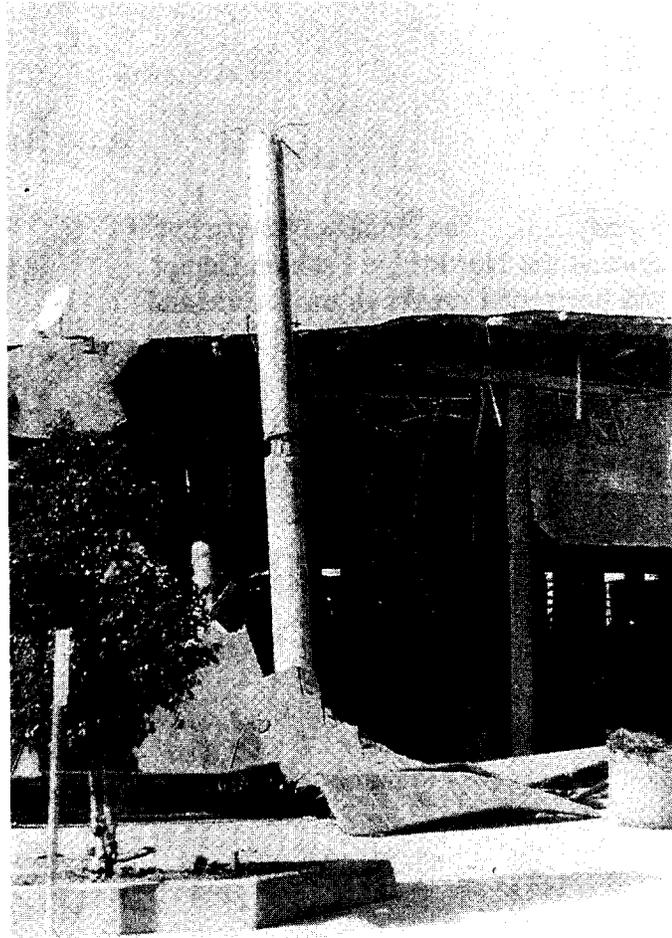
The collapse of large portions of the roof and floors of the 3-story concrete Bullock's department store at the Northridge Fashion Center could have caused more deaths than any other single building failure in this earthquake. Many multi-story columns were left intact as the concrete slab floors and roof fell on top of each to the basement, presumably due to punching shear failure of the slabs. The remaining-standing columns showed no evidence that slab reinforcement had been continuous through the columns (Figure 11).

Figure 11 A portion of the concrete waffle slab roof and the interior floor slabs at the Bullock's department store at the Northridge Fashion Center mall fell to the basement, leaving many of the columns standing. No reinforcing steel can be seen in the remaining columns that would have connected the columns to the floor slabs.

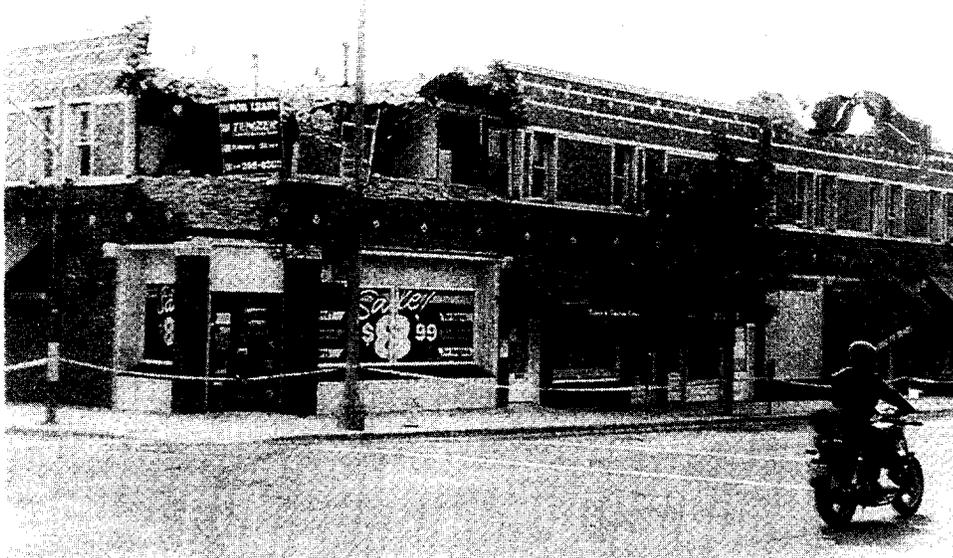
Figure 12 Damage to unreinforced masonry buildings, even those that had been rehabilitated, was common. Upper stories and corners were particularly vulnerable to damage. The rows of light-colored diamonds on the face of this building are the end plates of through-bolts used to connect the wall to the floor joists, a typical rehabilitation technique. The remains of parapet braces can be seen on the roof.

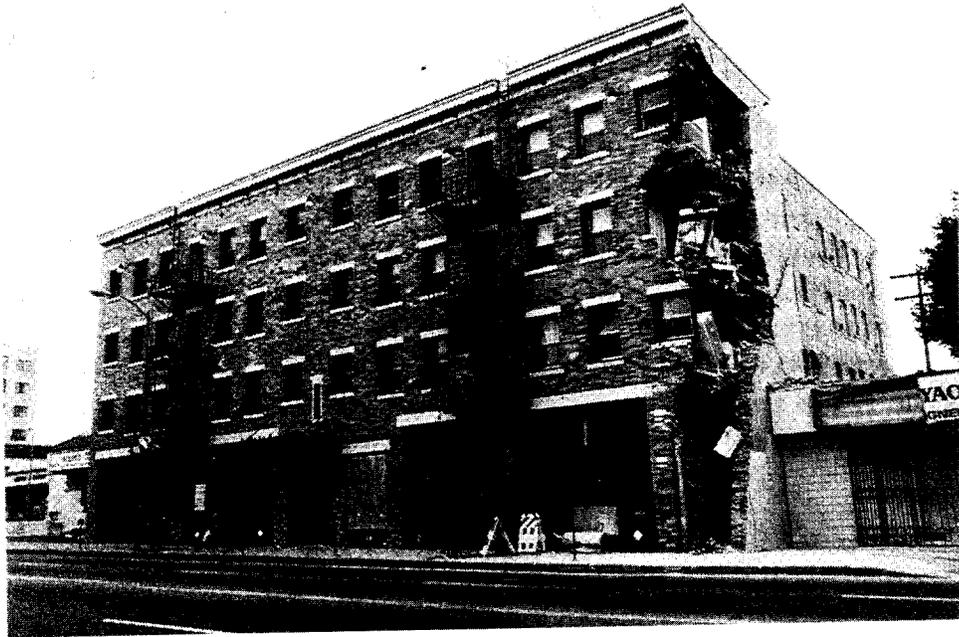
Figure 13 The corner of this rehabilitated unreinforced masonry apartment building in East Hollywood crumbled on all four stories.

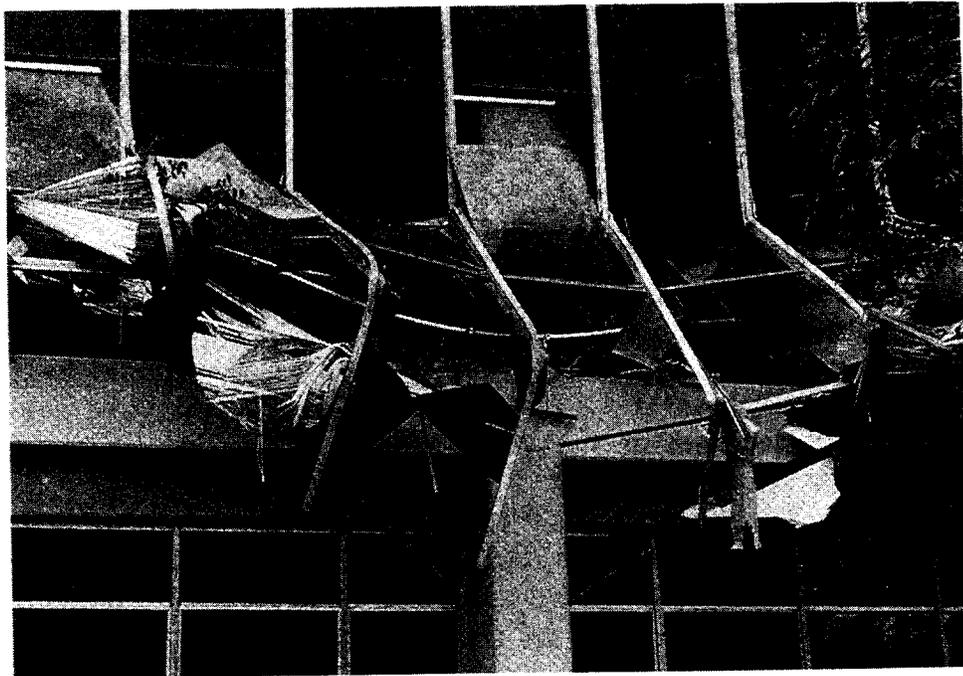
The Kaiser Permanente office building on Balboa Boulevard in Northridge was badly damaged. The second story columns disintegrated, causing the upper stories to collapse onto the first story, which remained intact (Figure 14). The bare frame exposed by the damage suggests that the buildings had a strong-beam/weak-column configuration (Figure 15). The damage appears to have initiated at the joints.

Figure 14 The second story of the concrete frame Kaiser Permanente office building on Balboa Avenue in Northridge completely collapsed. The first story was relatively undamaged, suggesting it was far stiffer than the story above.

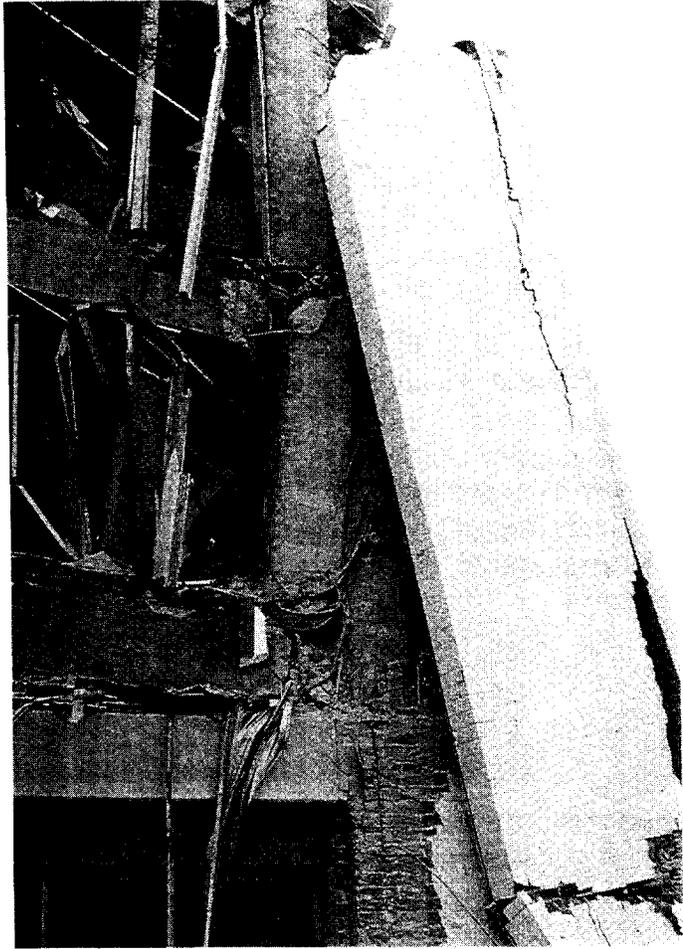
Figure 15 The exposed concrete frame of the Kaiser Permanente building, revealing deep beams, suggests that the building had a strong-beam, weak-column configuration. Except for the second story columns, the columns and beams remained intact while the joints disintegrated.

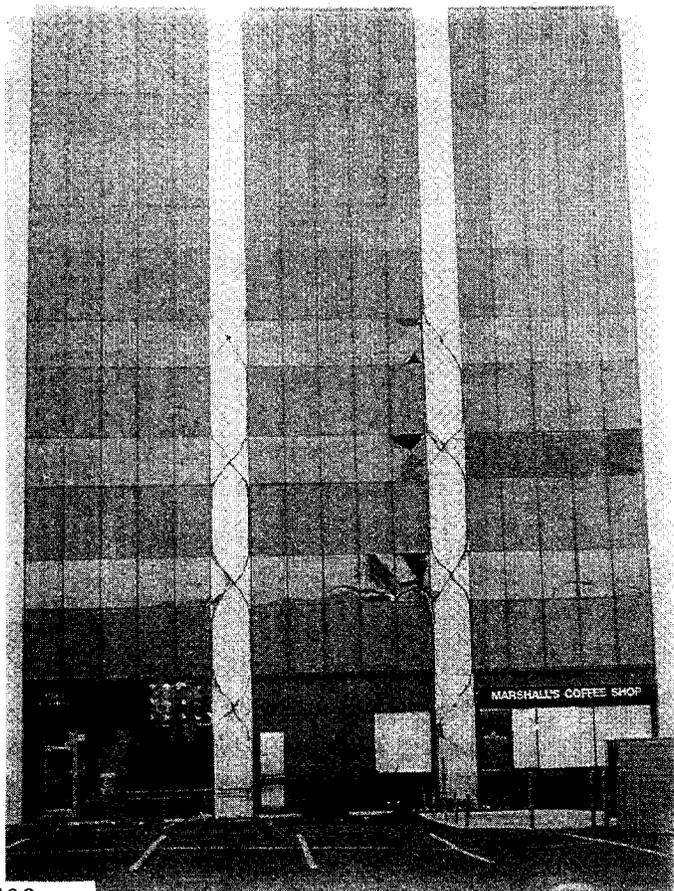
The L-shaped concrete frame Barrington Building in West Los Angeles also had damage concentrated in the second story columns (Figure 16). The horizontal architectural panels stiffened the lower half of the columns at each story, creating a short-column effect.

Figure 16 The stiff infill panels of the Barrington Building effectively shortened the concrete columns, forcing all the displacement into the column sections bounded by windows. Diagonal X-cracking decreased in severity towards the top of the building.

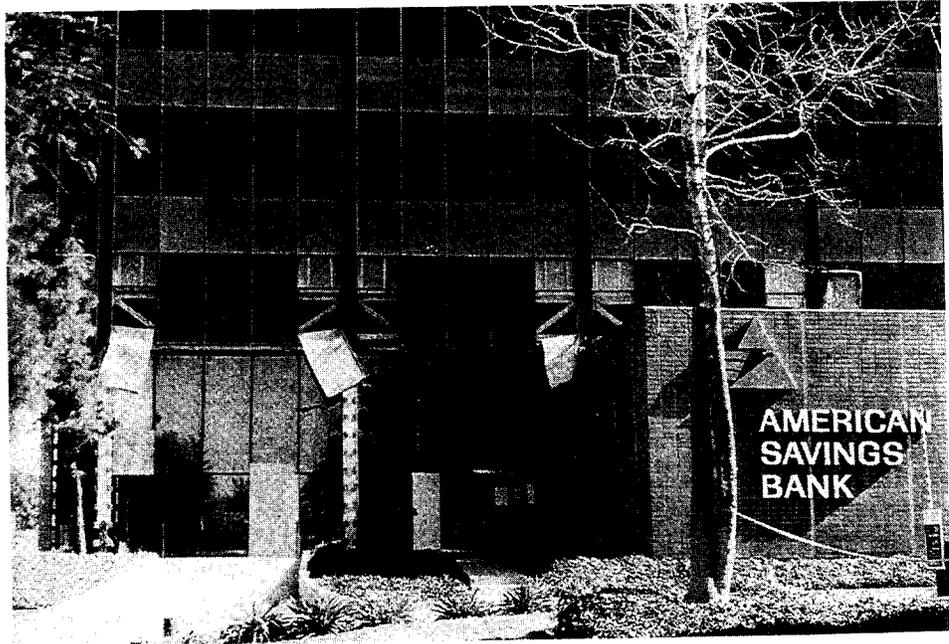
A steel-frame office building on the west side of Topanga Canyon Boulevard in Canoga Park, housing the American Savings Bank, experienced significant movement in its first story columns (Figure 17). A nearly identical building on the same site, oriented at right angles to the first, had only minor damage to glass at the first story. The first story column heights of the two buildings differed significantly: the ones in the undamaged building were considerably shorter than the ones in the damaged structure.

Figure 17 The first-story columns of the steel-framed building housing the American Savings Bank on Topanga Canyon Road in Canoga Park flexed during the quake and ended up slightly displaced from their original positions.

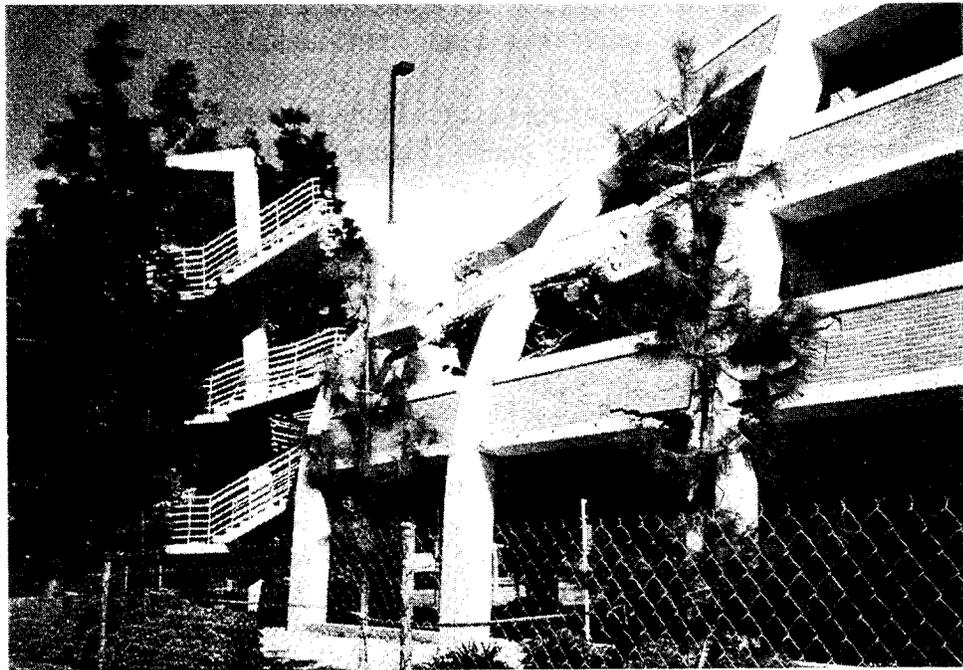
Figure 18 The three-year old four-level parking garage at the Northridge campus of California State University partially collapsed in the earthquake. The collapse apparently started at the interior, causing the exterior walls to be pulled in to the middle of the structure. Precast concrete "trees" were connected to form a moment-resisting frame at the exterior of the structure.

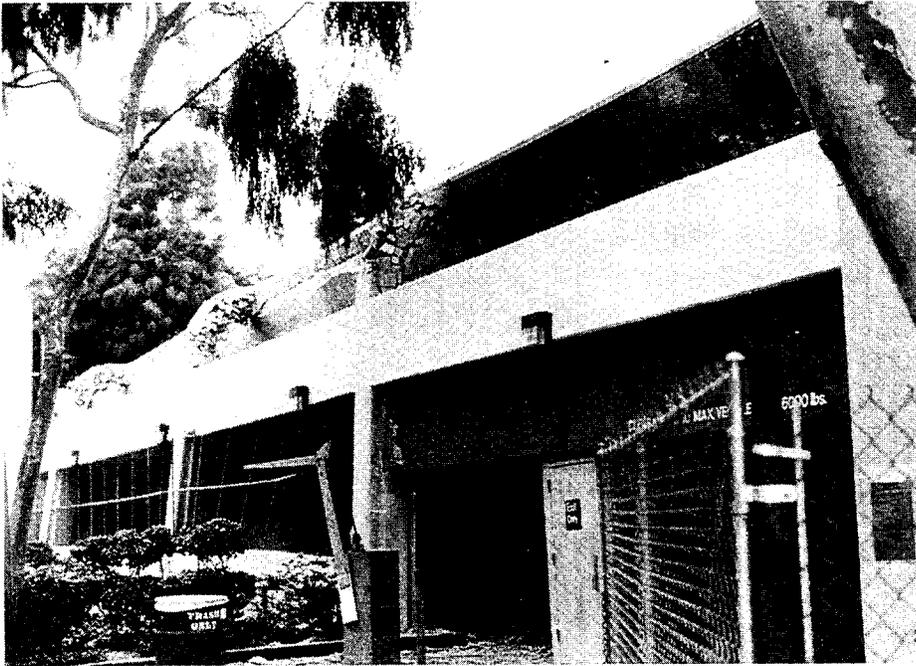
Kaiser Permanente Medical Complex on Cadillac Avenue The five-level parking garage in West Los Angeles experienced a similar collapse. All four facades were pulled inward, suggesting that interior damage precipitated the failure (Figure 19). The garage was a post-tensioned, cast-in-place concrete structure with shear walls providing the lateral-force resisting system at the east and west ends, and moment frames at the north and south perimeter. The shear walls were cracked horizontally throughout their height due to the out-of-plane bending (Figure 20).

Figure 19 The cast-in-place concrete parking garage at the Kaiser Permanente Hospital complex in West Los Angeles collapsed in on itself. The moment frame that provided lateral resistance on the south face of the structure could not resist the out-of-plane forces apparently caused by the collapse of interior elements.

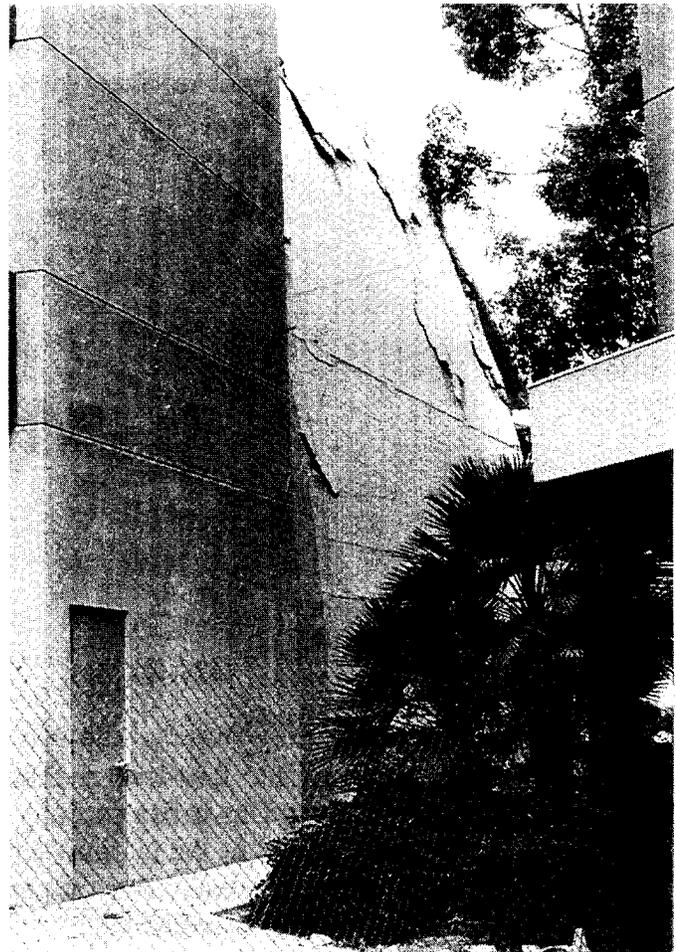
Figure 20 - At the east and west faces of the Kaiser Permanente Hospital parking garage, shear walls made up the lateral force resisting system. Both walls had horizontal cracks caused by the out-of-plane bending when the walls were pulled inward. Neither wall had major diagonal cracking, suggesting that the lateral load was never fully delivered to the walls. The stair towers remained erect. The east wall and stair tower are shown here.

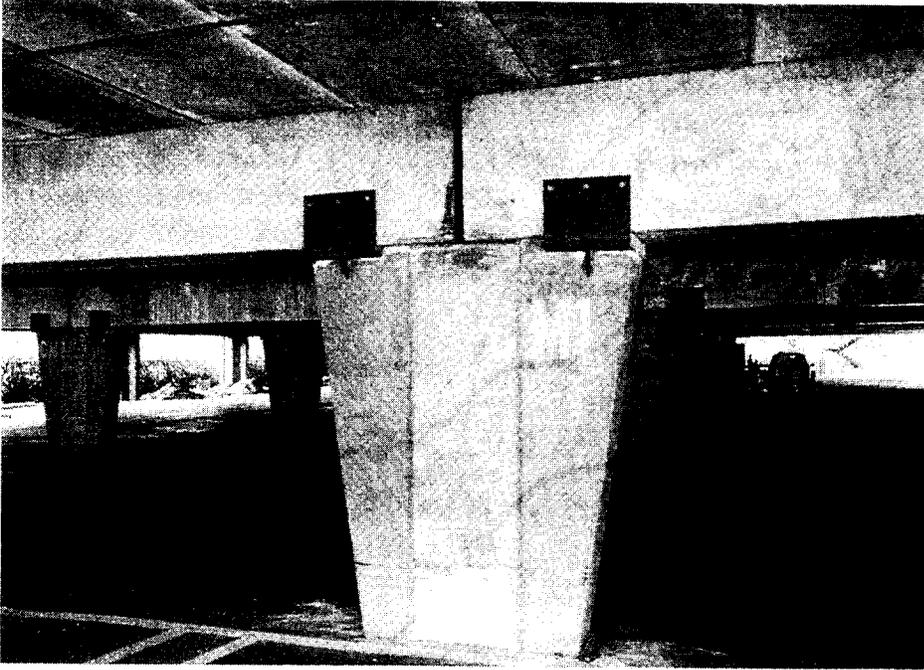
Trans World Bank Parking Structure The two-level concrete parking structure adjacent to the Trans World Bank in Sherman Oaks had been seismically strengthened after suffering serious damage in the 1971 San Fernando quake. Flared extensions were cast next to the interior columns along their north-south axes (Figure 21), creating short wing walls supporting the precast beams.

Figure 21 The interior columns of the two-level parking garage at the Trans World Bank in Sherman Oaks had been seismically strengthened after it suffered damage in the 1971 San Fernando quake. The interior columns fared well in the 1994 Northridge quake.

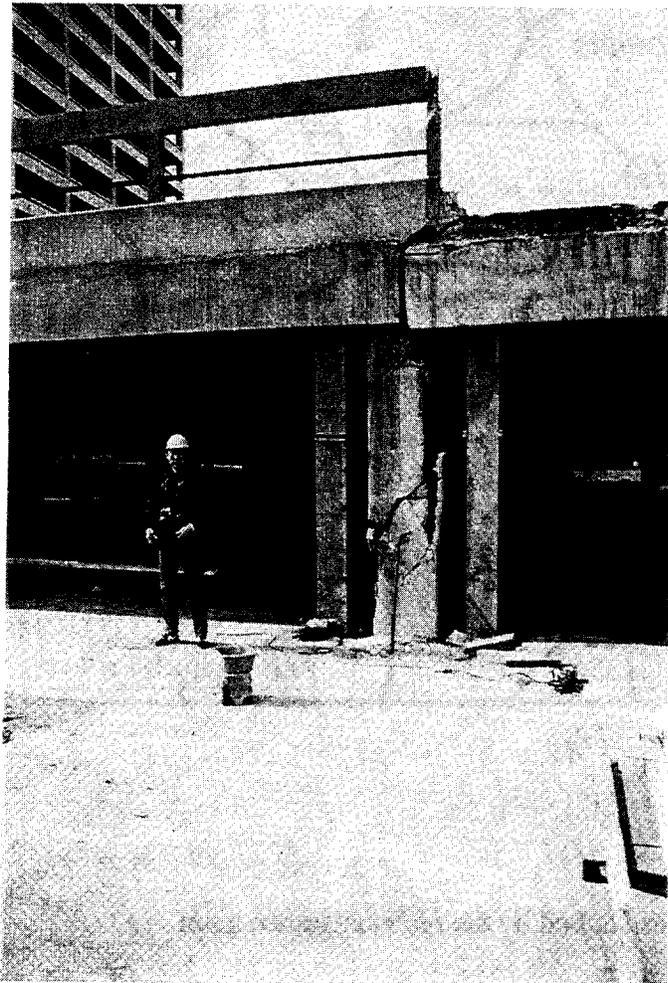
The unrehabilitated exterior columns were badly damaged in the Northridge earthquake (Figure 22).

Figure 22 The exterior columns of the Trans World Bank parking garage, which had not been strengthened, were badly damaged.

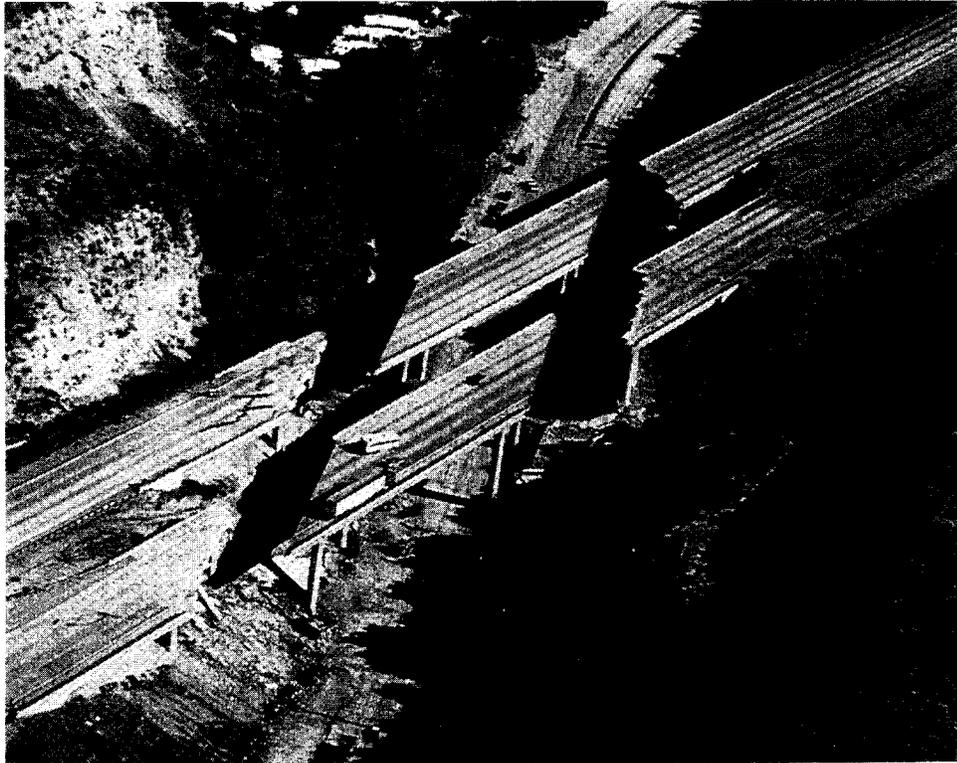
This bridge was designed in 1964 and constructed in 1967. It carries Interstate 5 over Gavin Canyon, about 3 km north of the intersection of Interstate 5 and State Route 14. An aerial photograph of the damaged bridge, after demolition had begun, is shown in Figure 24, and a ground level view is shown in Figure 25. The structure consists of two parallel bridges, with about a 66 degree skew alignment. Each bridge is composed of five spans. Each bridge has four two-pier bents, and there is a structural hinge near each of the two center bents. The superstructure consists of reinforced concrete box girders, and the central portion (between hinges) is post-tensioned. The bridge survived the 1971 San Fernando earthquake with virtually no damage. In 1974, the hinges were retrofitted with cable restrainers. The seat length at the hinges is 200 mm, which by current design standards would be considered inadequate, especially for a structure of this size and flexibility.

Figure 24 Aerial view of the bridge at Gavin Canyon, looking to the east, showing appearance of the four end spans shortly after demolition had begun

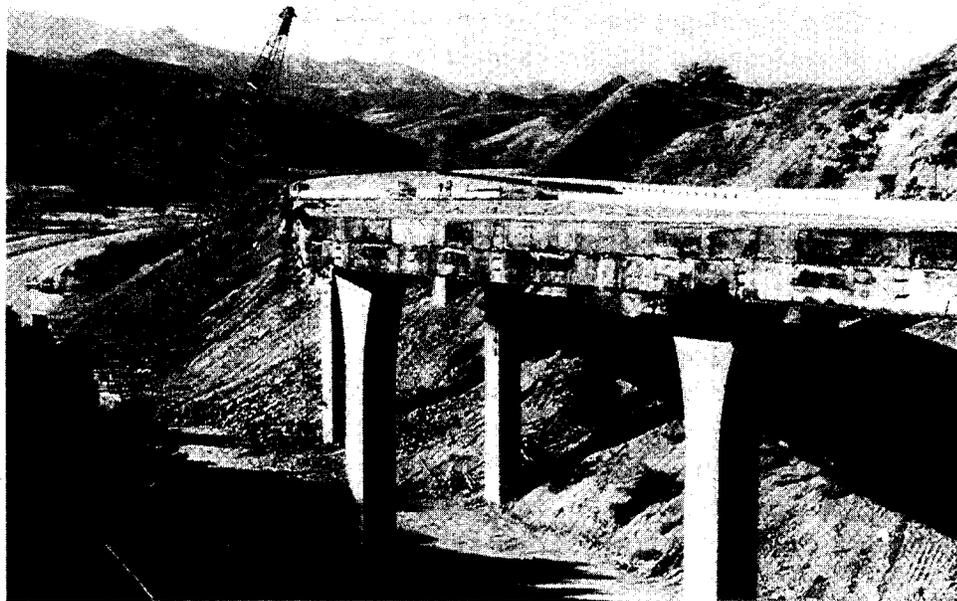
Despite the presence of cable restrainers at the hinges, failure of three of the four end spans of the bridge was apparently initiated by the spans falling off the hinge seats. The fourth end span, at the far western corner of the bridge, partially came off its hinge seat but did not collapse. After support was lost at the hinges, a triangular portion of three of the end spans collapsed. It is likely that the skewed alignment of the bridge was an important contributing factor in this failure. The skewed alignment

Figure 25 Ground level view of the southbound bridge at Gavin Canyon, looking to the northwest, showing the hinge bearing seat near Bent 3.

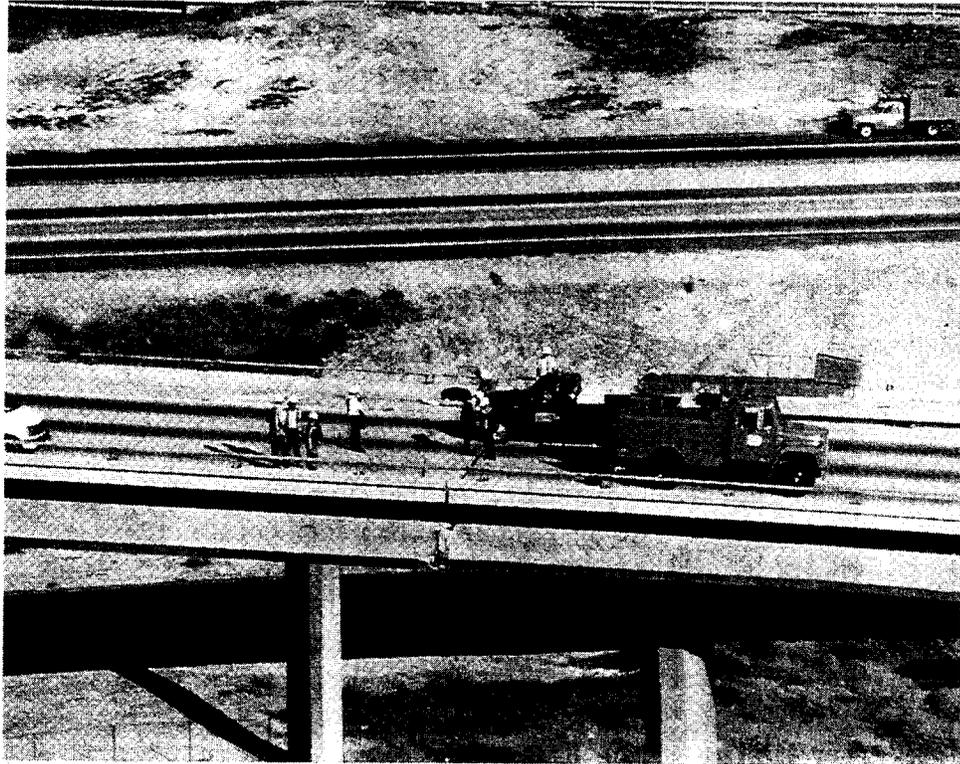
Figure 26 Example of pounding and offset at a hinge in the SR14/I5 interchange

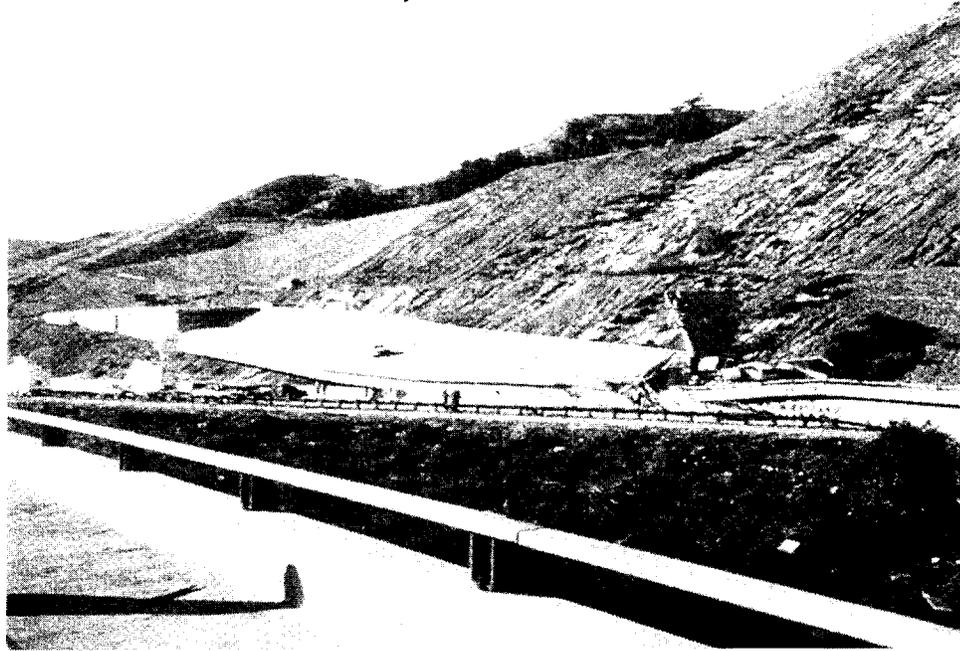
Figure 28 Overview of the collapse of the SR14/I5 Separation and Overhead, Ramp C, looking to the south at Abutment 1. Pier 3 can be seen at the right of the photograph (Courtesy of EERC)

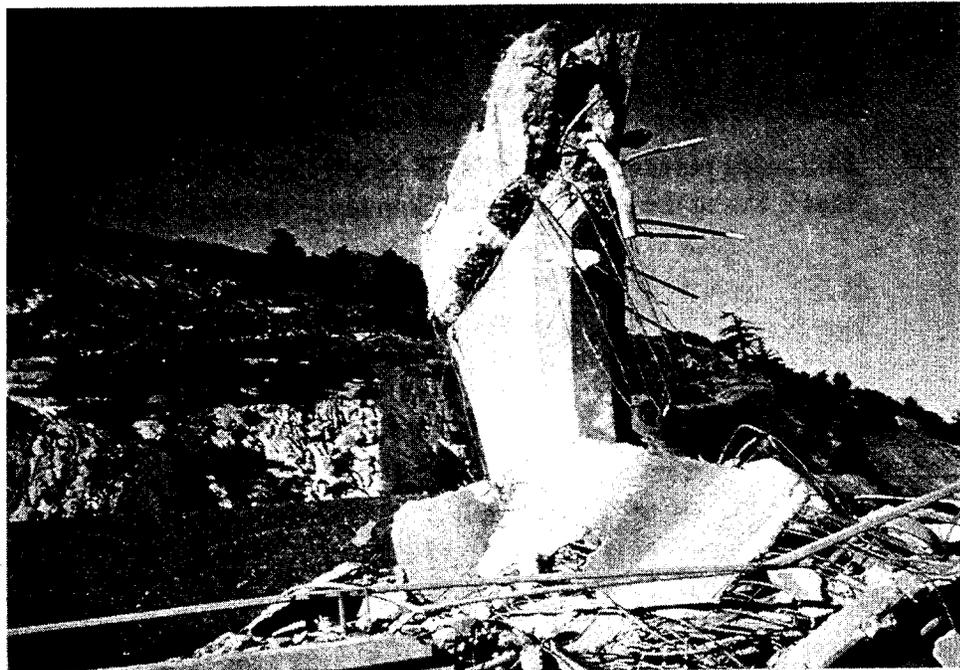
Figure 29 Damage at Pier 3 of the SR14/I5 Separation and Overhead, Ramp C, looking to the west (Courtesy of EERC)

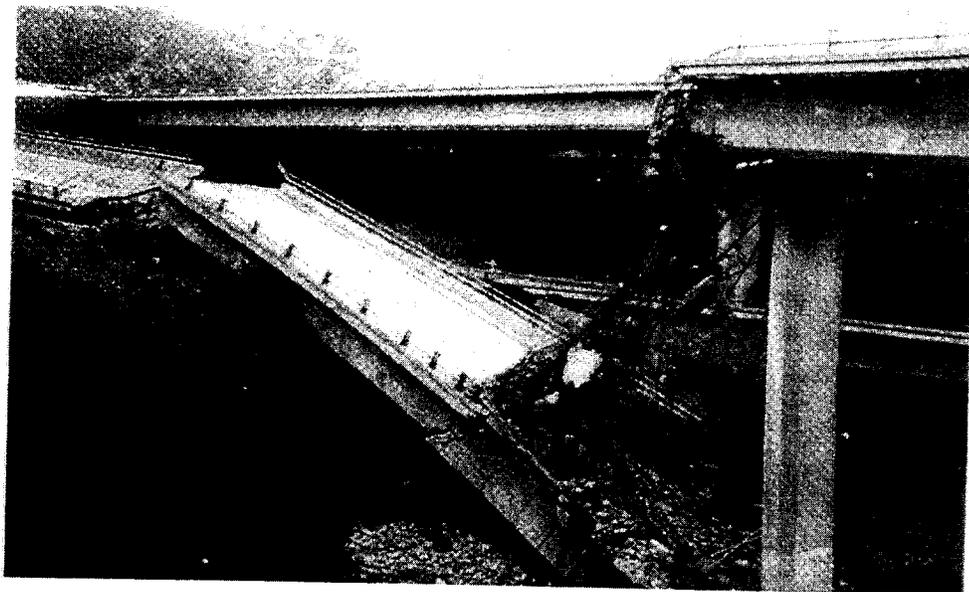
Figure 30 Collapsed portion of the SR14/I5 North Connector Overcrossing, looking east.. Pier 2 was at the left, near the broken hinge on the ground (Courtesy of EERC)

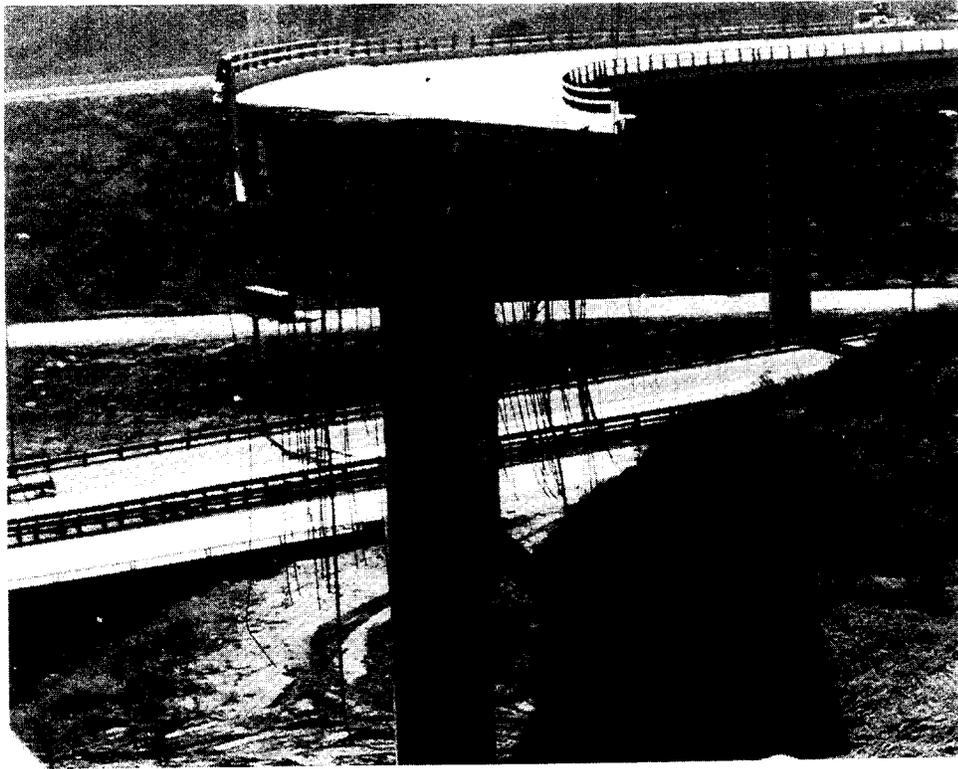
The collapse in the Northridge earthquake appears to have been initiated by the failure of Pier 2. After Pier 2 failed, the simply supported span between Abutment 1 and the hinge near Pier 2 collapsed, and, as shown in Figure 31, the superstructure failed in bending near Pier 3 due to a large negative moment. Pier 2 completely disintegrated, as shown in Figure 32. This is the shortest pier in the structure, so it is likely that it attracted a high level of lateral force, was damaged in shear, and finally collapsed in compression. Pier 10 is similar in height to Pier 1, but the quantities of lateral reinforcement in Pier 10 are greater than those in Pier 1. This is because Pier 2 had already been completed, but Pier 10 had not yet been constructed, when the 1971 earthquake occurred. Following the 1971 earthquake the plans for Pier 10 were revised to provide increased lateral reinforcement.

Figure 31 View of the flexural failure at Pier 3 of the SR14/15 North Connector Overcrossing, looking to the south

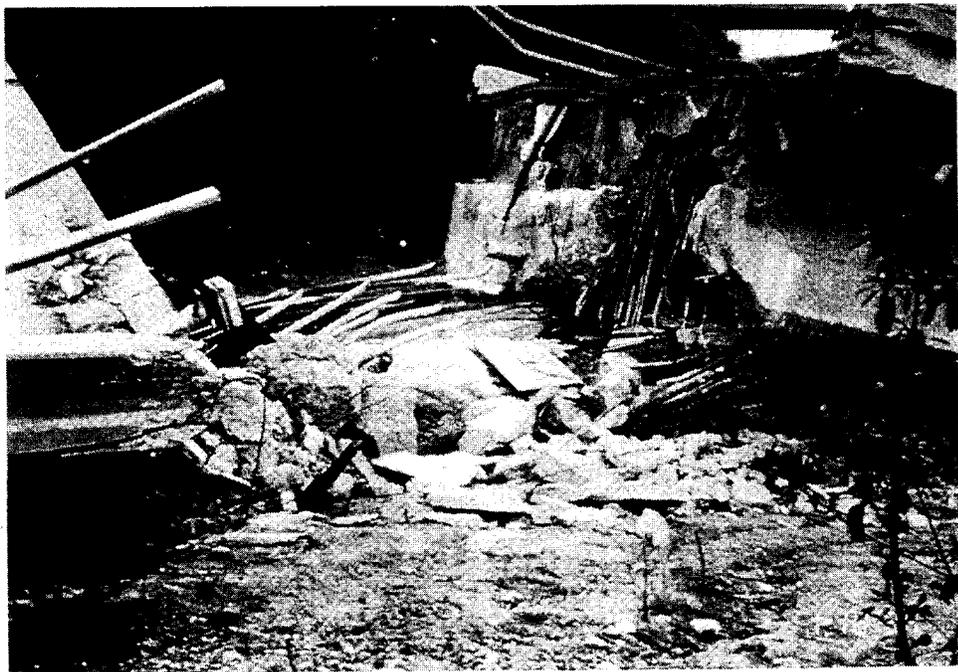
Figure 32 View of crushed Pier 2 and the hinge near Pier 2 (Courtesy EERC)

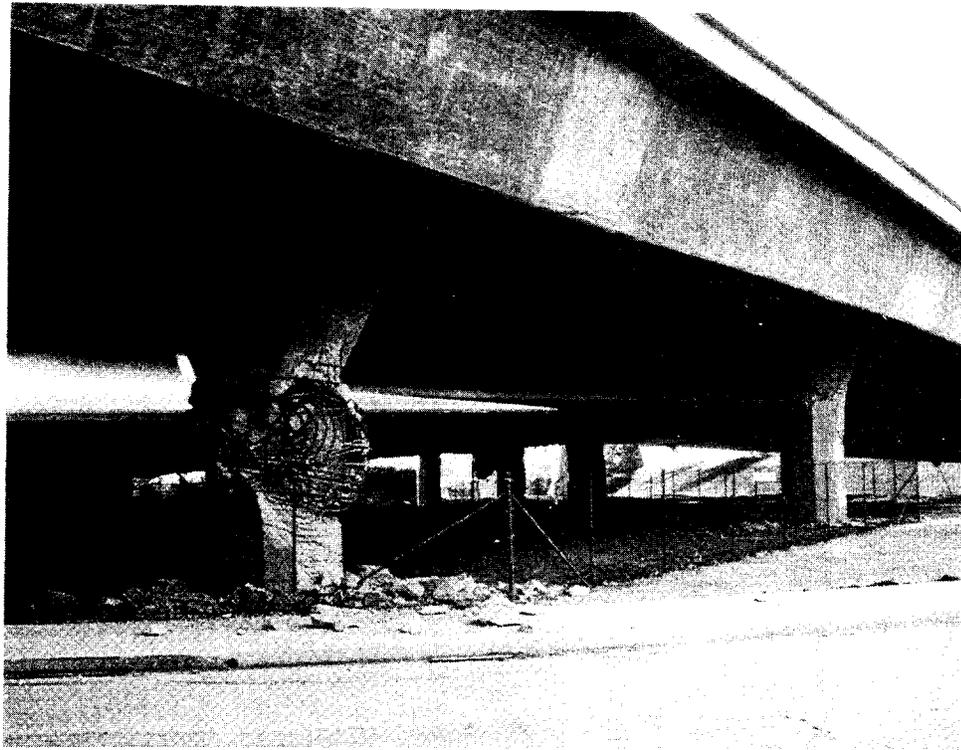
Figure 33 Damage to piers of the SR118 Mission-Gothic Undercrossing, looking to the northwest at the north face of the westbound bridge, Bents 3 (foreground) and 2.

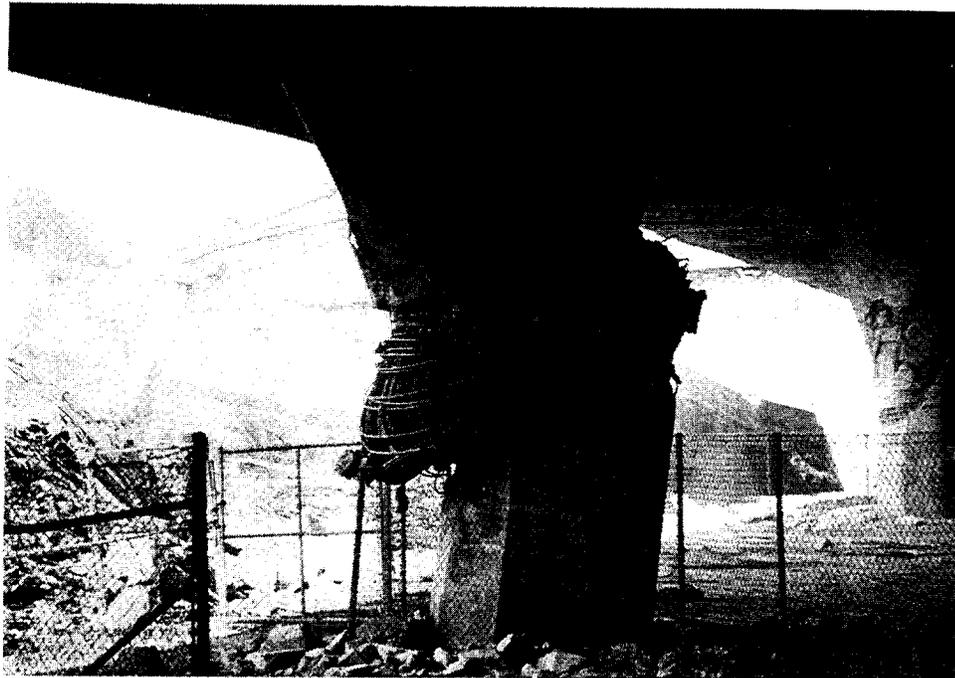
Figure 34 Damage to a pier of the SR118 Mission-Gothic Undercrossing, looking to the northwest at the southernmost pier of Bent 3 of the westbound bridge.

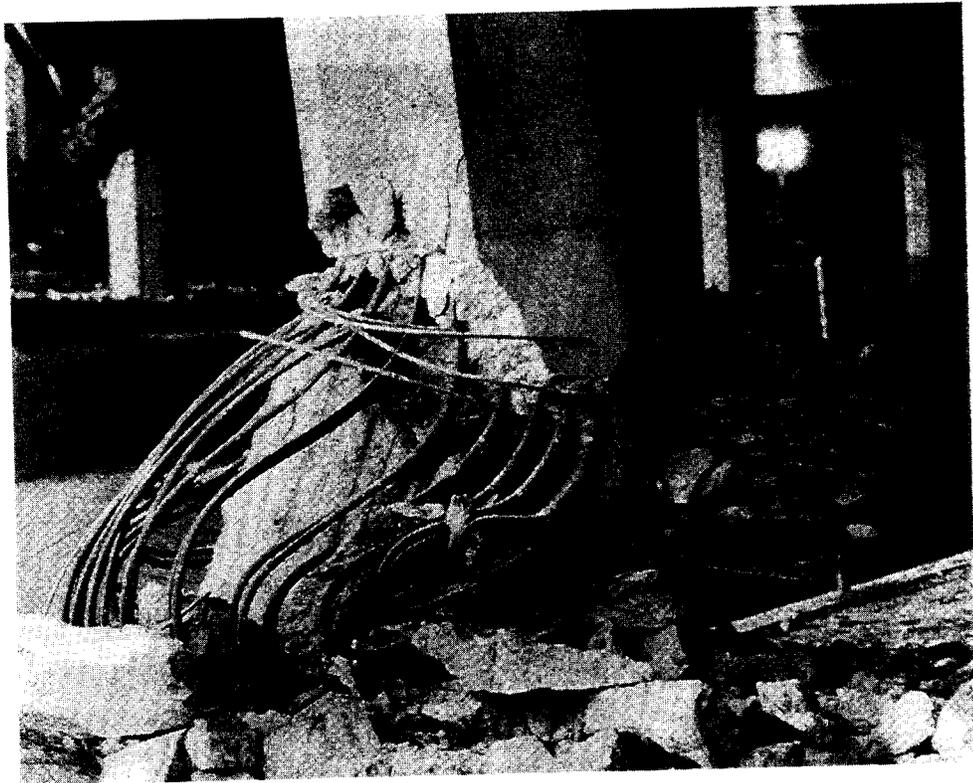
Figure 35 Damage to pier 3S-1 of State Route 118 at Bull Creek Canyon Channel, looking to the northwest
