The January 17, 1994, Northridge Earthquake, California

H. S. Lew¹, Jim Cooper², Sam Hacopian³, Walter Hays⁴, and Mike Mahoney⁵

ABSTRACT

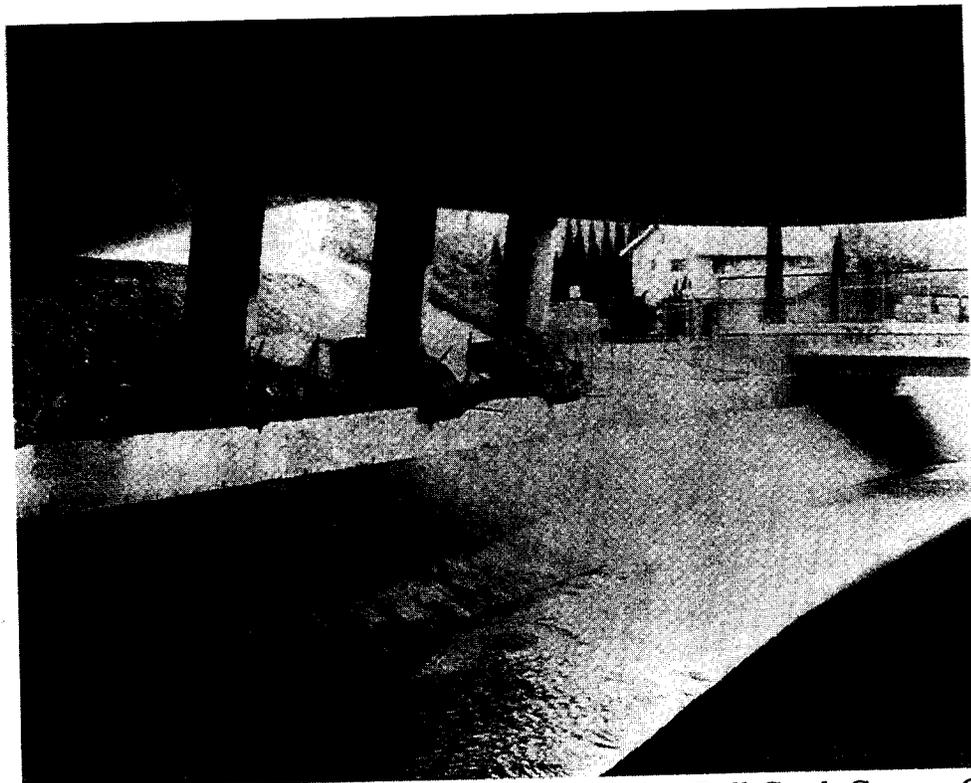
Figure 36 Damage to piers of Bent 3S of State Route 118 at Bull Creek Canyon Channel, looking to the southeast.

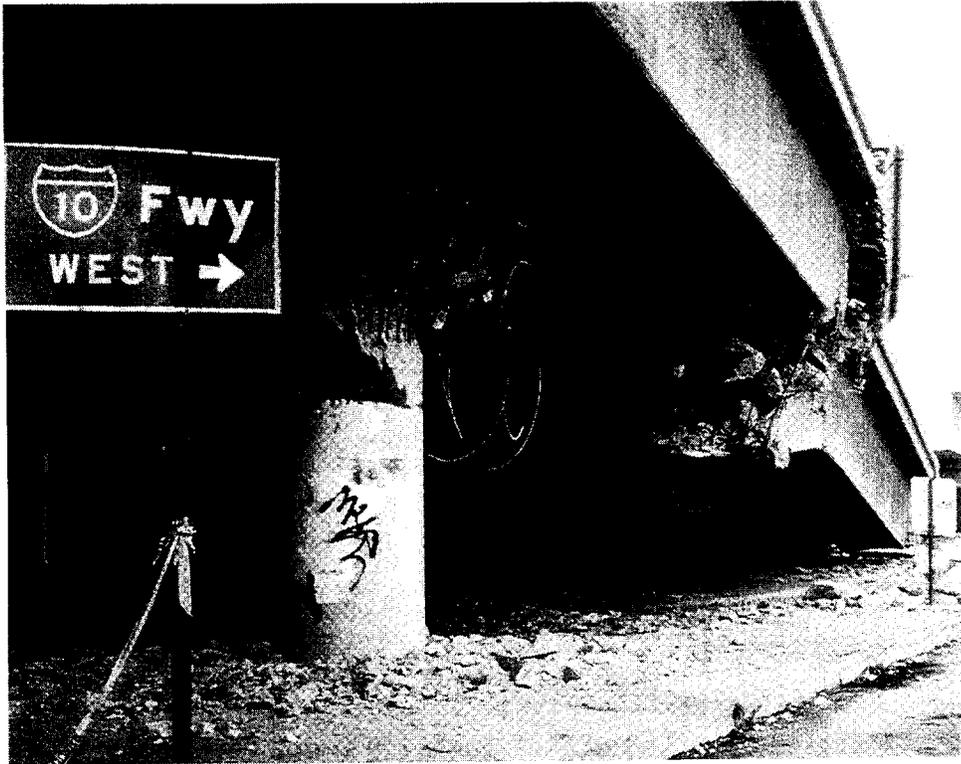
Figure 37 Collapsed westbound lane of I10 at Venice Blvd.; pier of Bent 7 in foreground

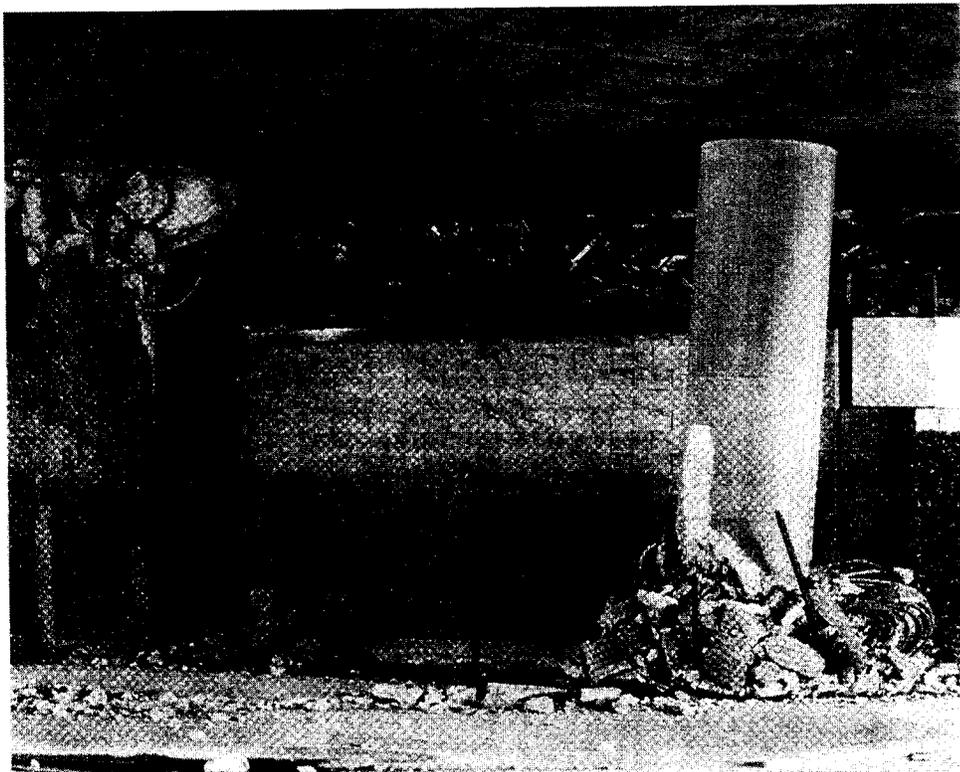
Figure 38 Failed piers in Bent 7 supporting westbound lane of I10 at Venice Blvd.

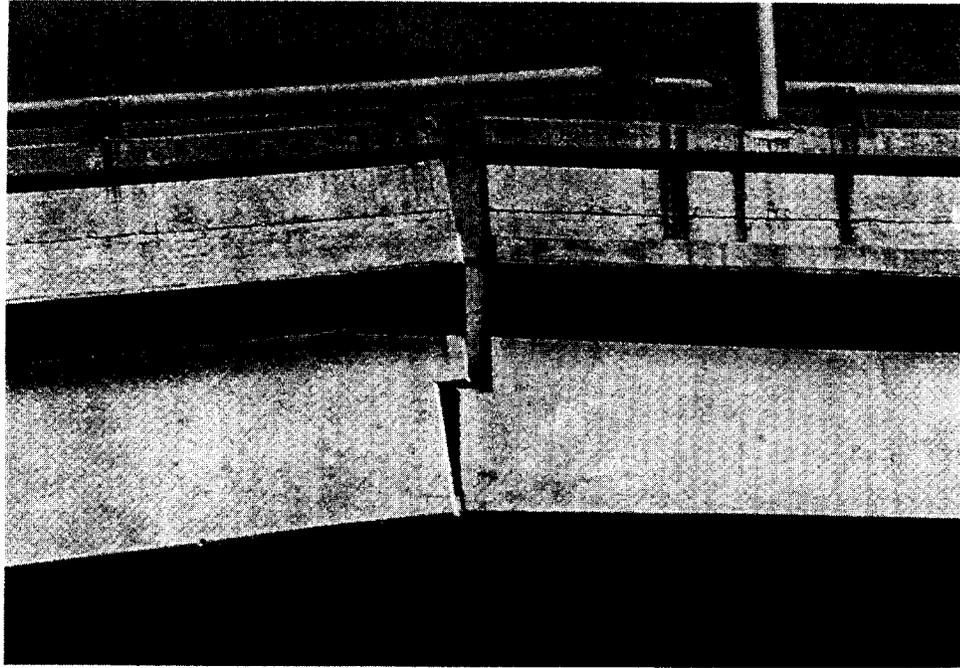
Figure 41 Hinge adjacent to Bent 4 of I 10 at Fairfax Ave.; cable restrainers prevented loss of support (Courtesy of EERC)

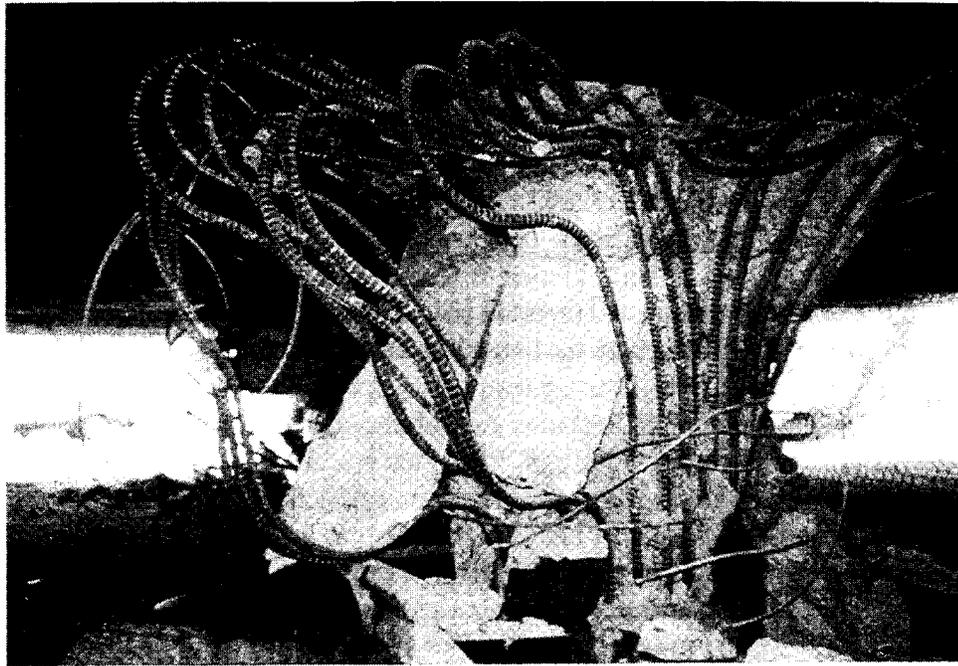
Figure 43 Failed column in Bent 3 of I10 at Fairfax Ave. (Courtesy of EERC)

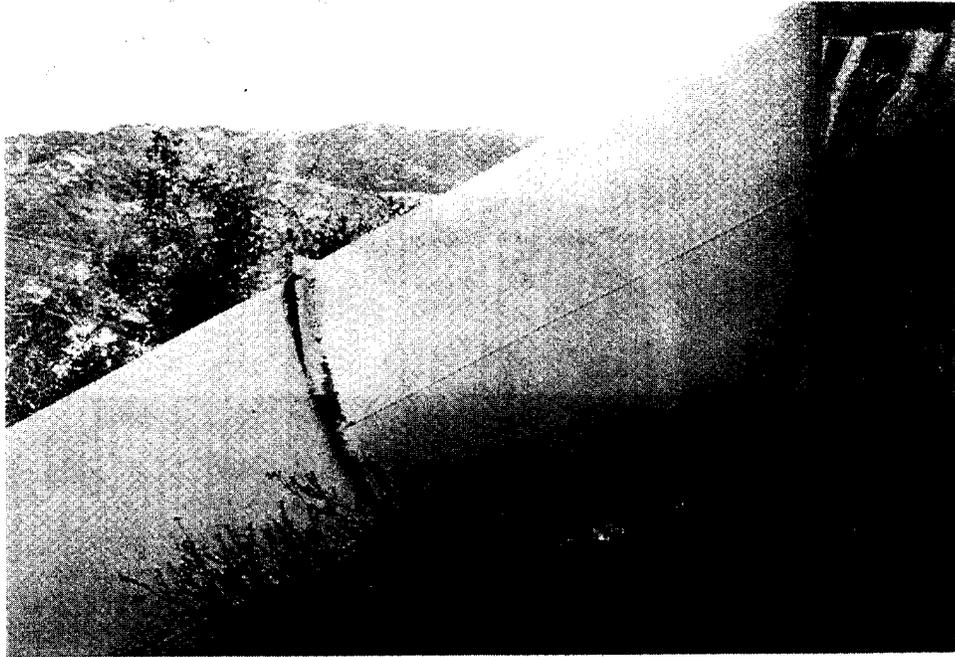
Figure 44 The steel pipeline at Terminal Hill separated from its supporting saddle at several places and pipe sections bulged at other locations along the alignment.

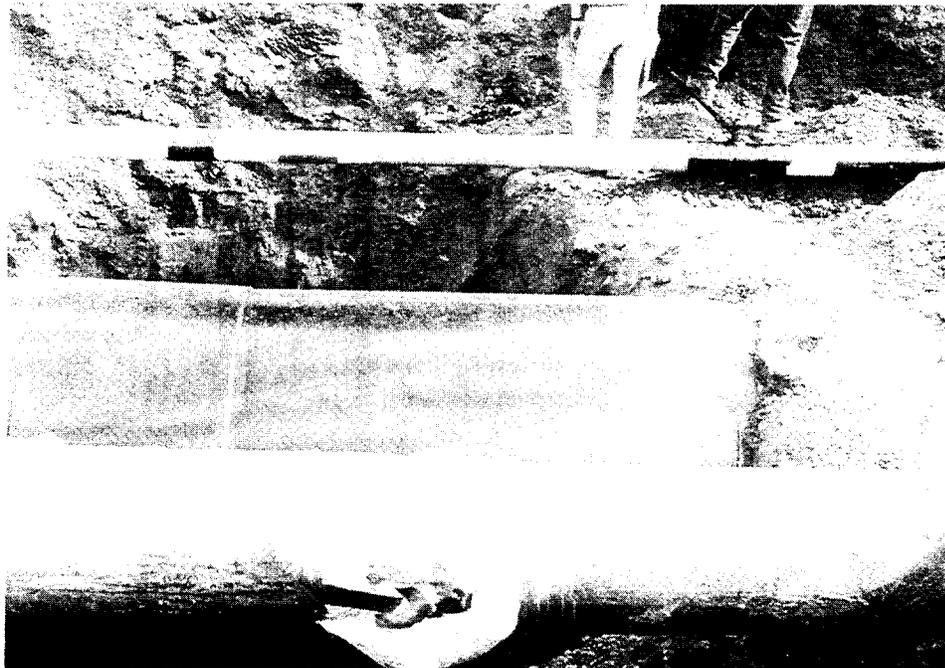
Figure 47 Ground contraction along Balboa Boulevard caused the rupture of a gas distribution line, the Rinaldi trunk water main, and a gas main.

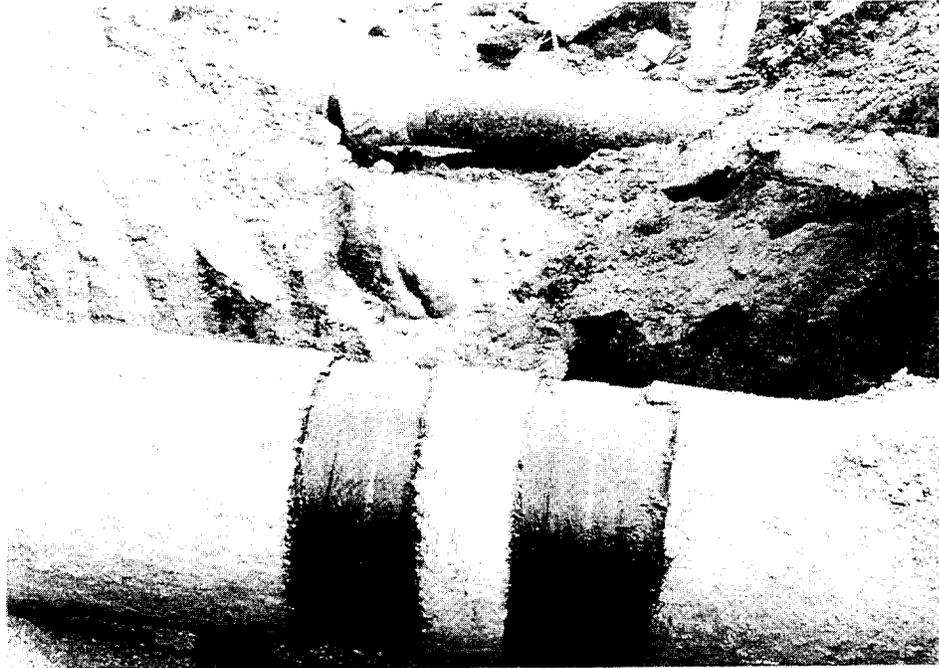
Figure 48 Ground extension along Balboa Boulevard resulted in the rupture of the same gas main and water main shown in Figure 47. The rupture of the gas main here caused a major fire that engulfed five houses.

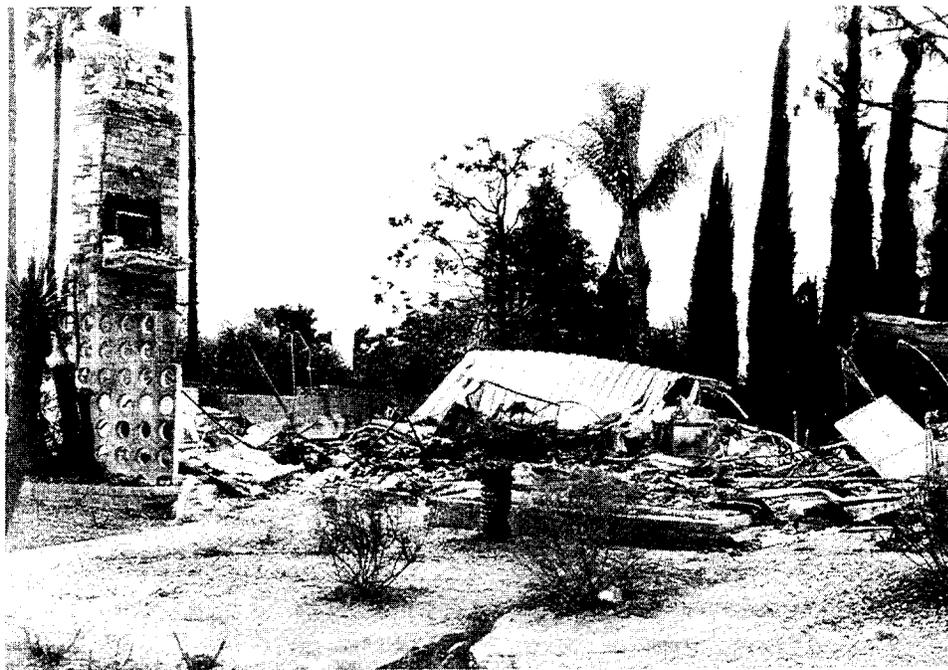
Figure 49 Houses destroyed by a fire resulting from the rupture of the 0.6-m gas main along Balboa Boulevard.

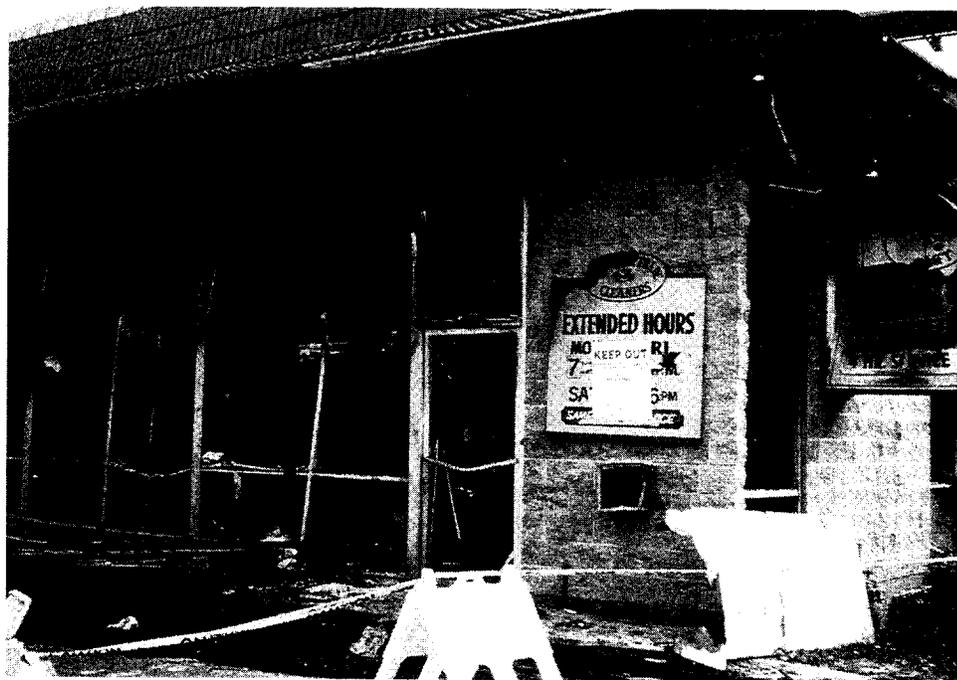
Figure 56 Fire damage in a single story commercial building.

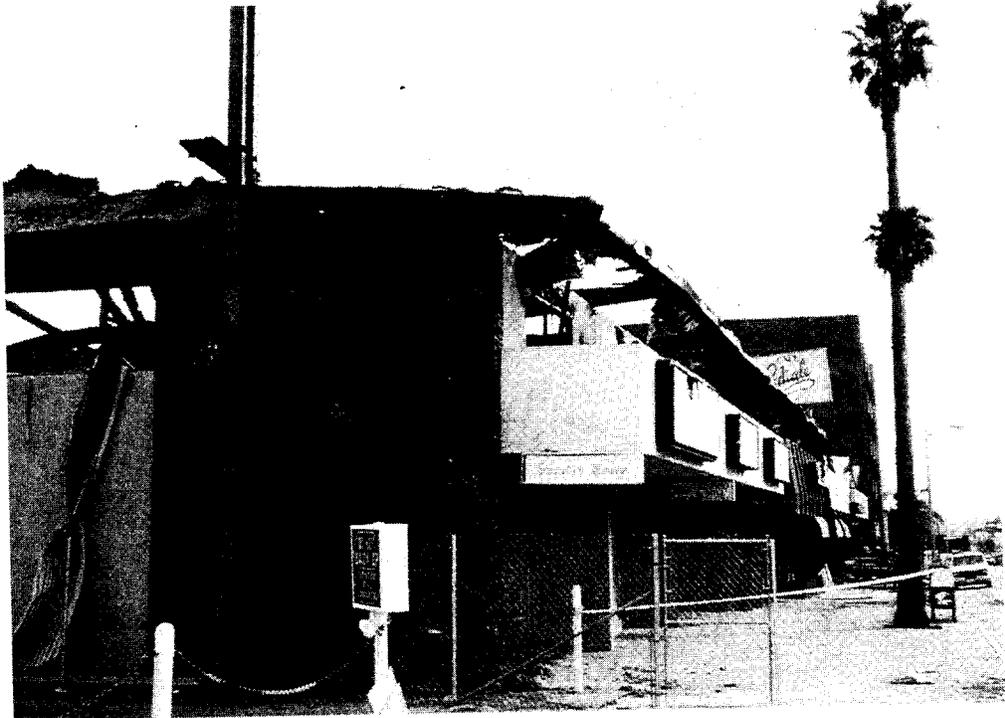
Figure 57 Fire damage in a two story commercial building.

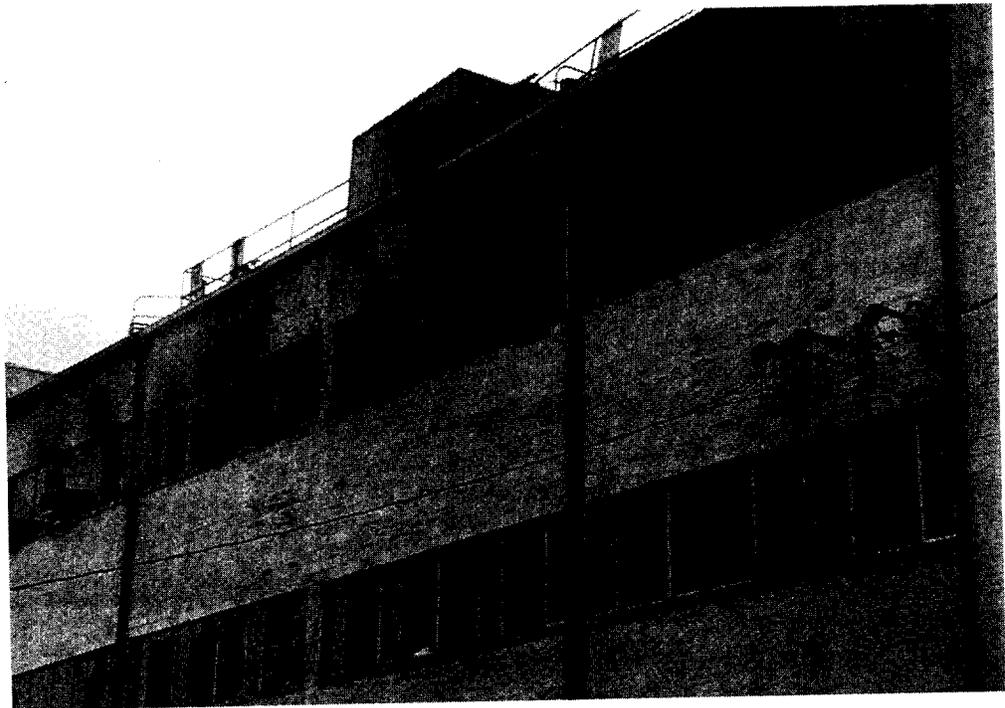
Figure 58 Fire damage in a three story commercial building.

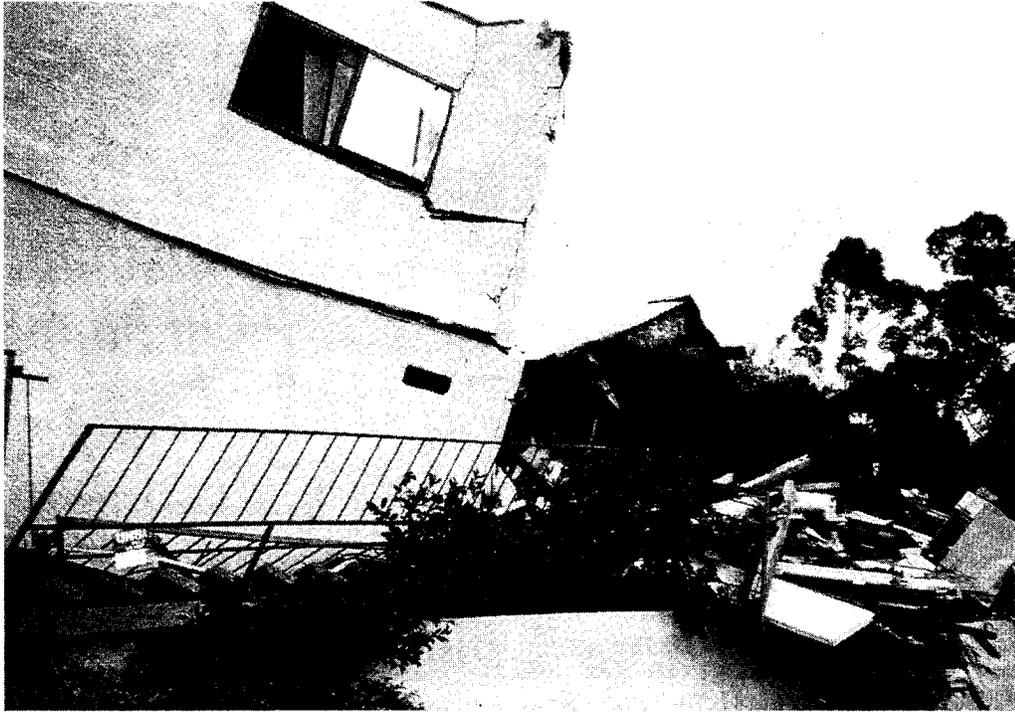
Figure 59 Partially collapsed apartment building with fire damage in the rear.

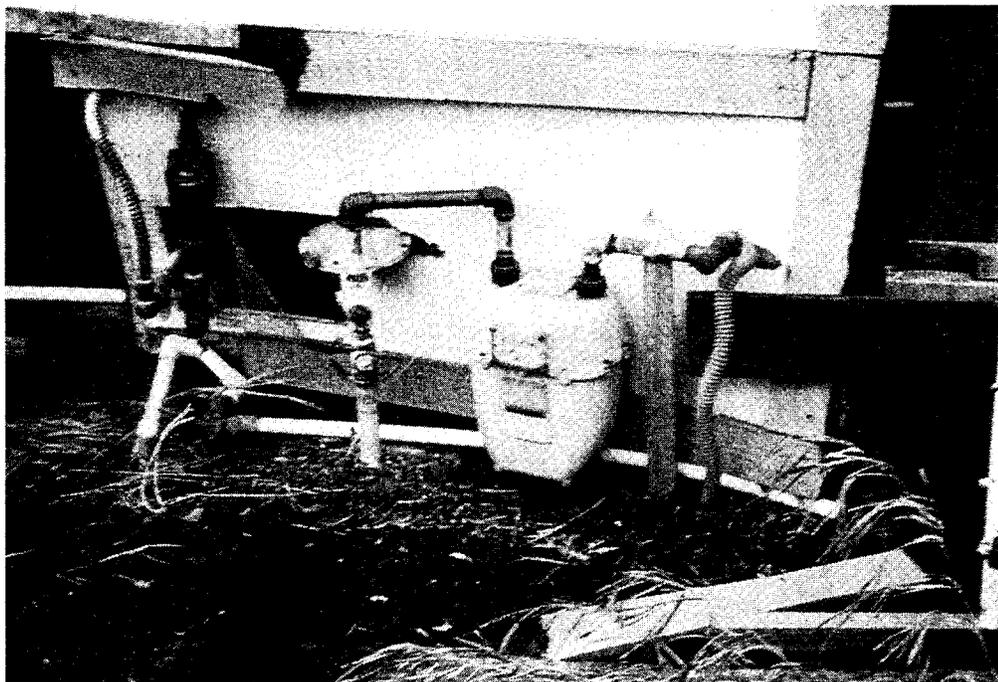
Figure 60 Damaged gas service in a manufactured housing development.

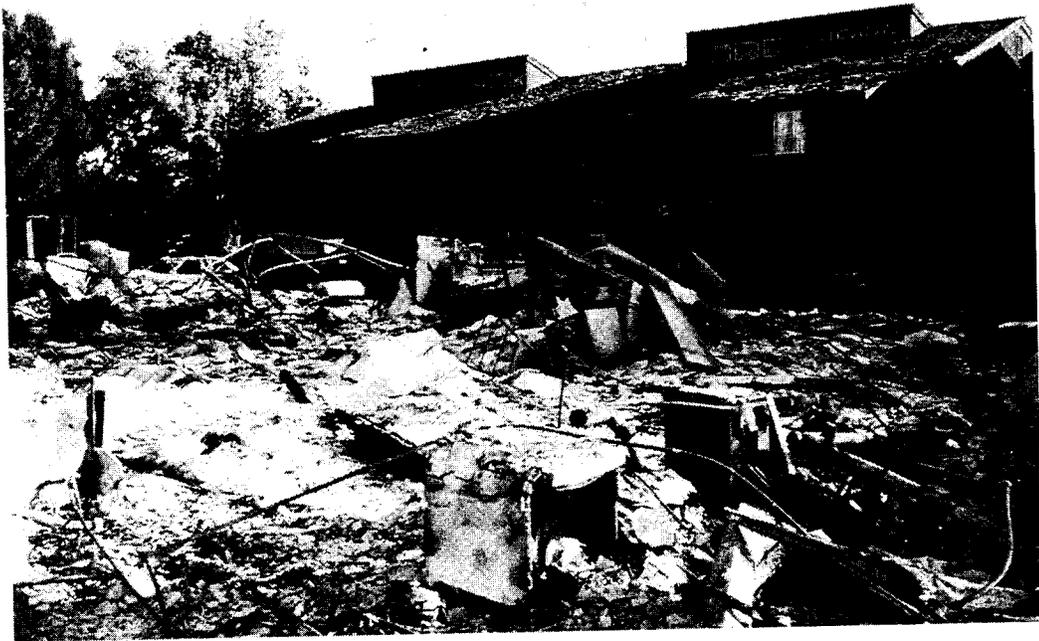
Figure 61 Multi-family residential building destroyed by fire.

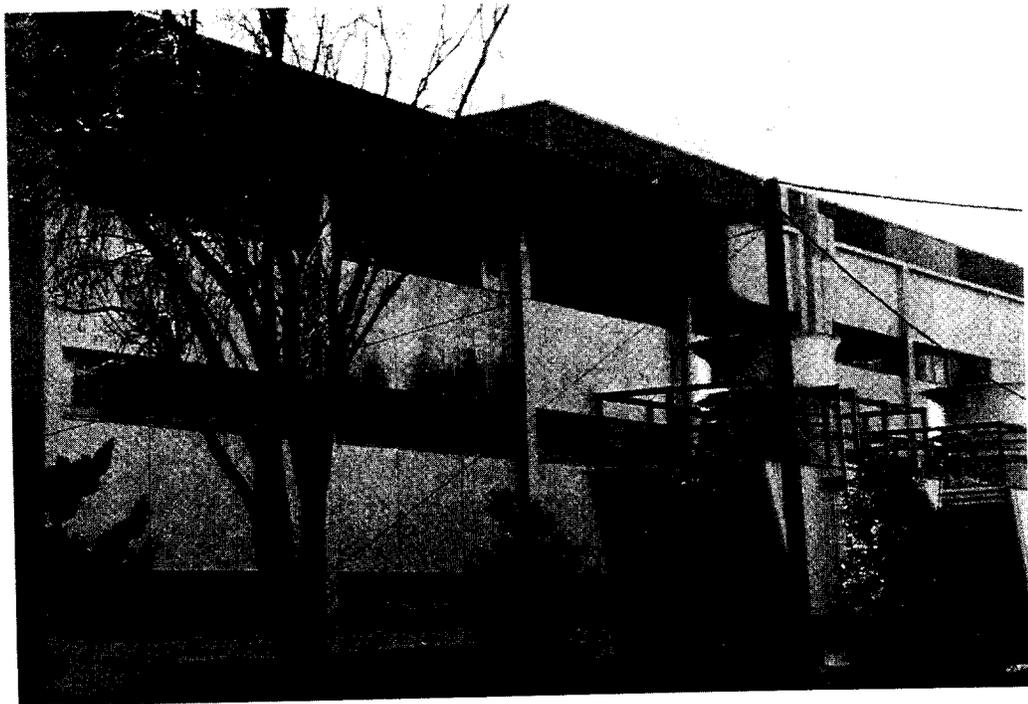
Figure 62 University science building damaged by fire.
