NIST GCR 98-757

**Guide to Improved Earthquake Performance of
Electric Power Systems**

Anshel Schiff
Stanford University

September 1998

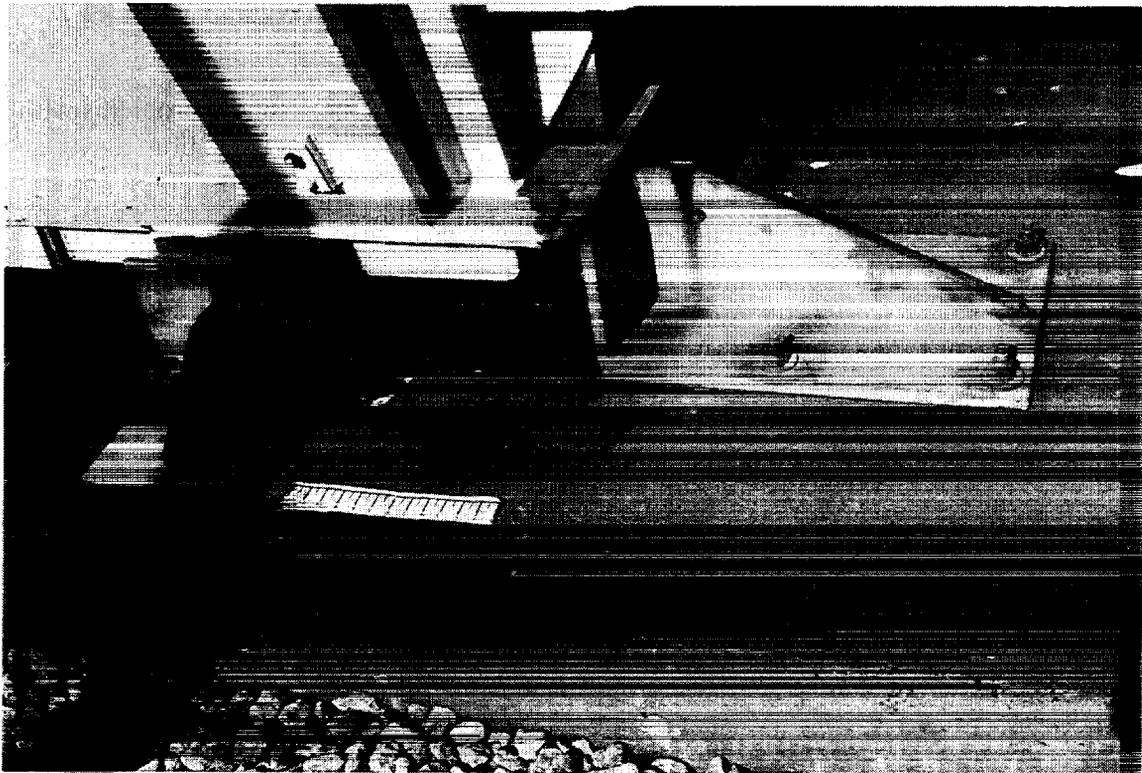
Figure 5.34 A bracket with a gusset was welded to a stiffener on the transformer case and bolted to the foundation slab.

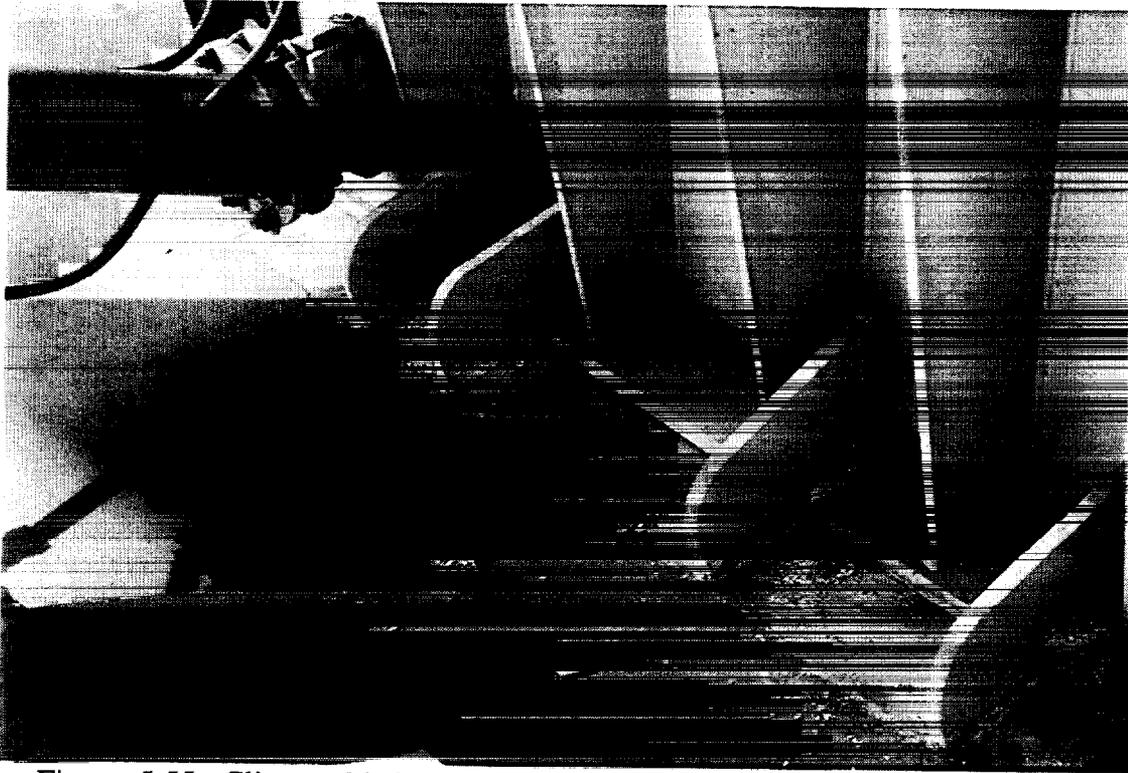
Figure 5.55 Clips welded to embedments were severely loaded due to large overturning moments and tipping of the transformer. The weld to the embedment was partially torn, embedment plates deformed, but the transformer was restrained. The lifting action probably caused impact loads when the transformer fell back to the slab.

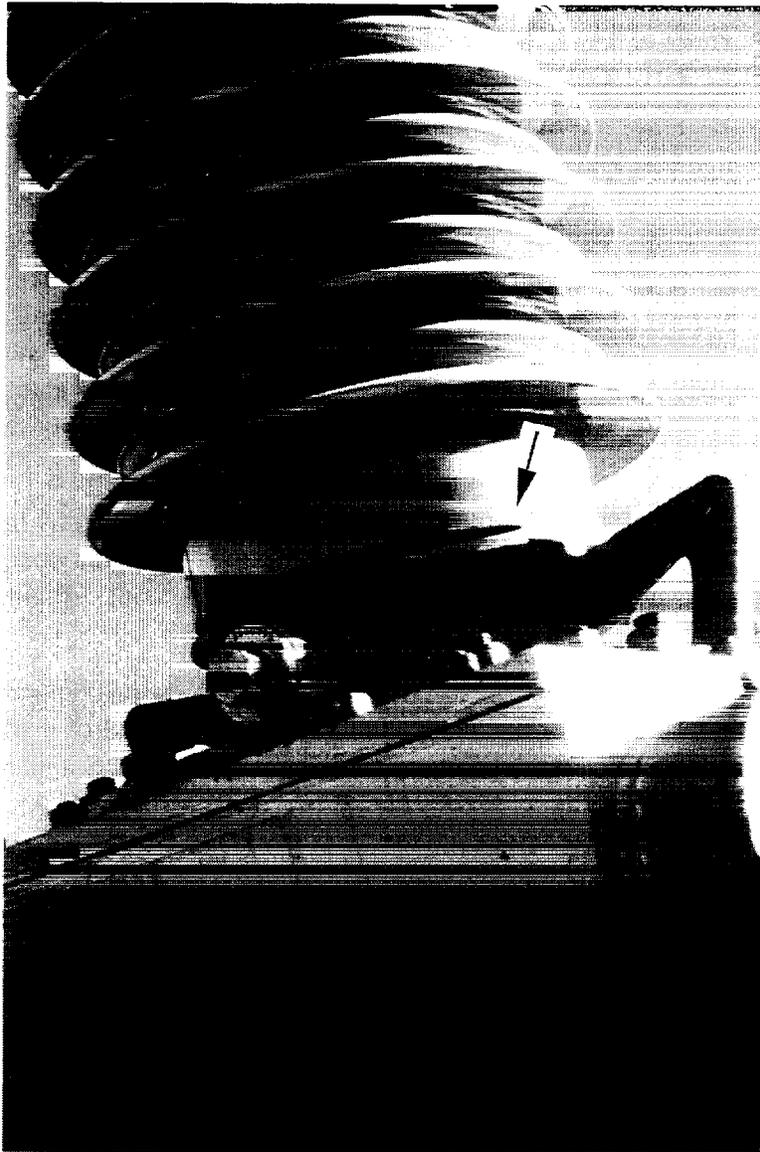
Figure 5.64 The metal flange supporting this transformer has cracked.

An unusual failure was the cracking of the metal flange that supported the bushing, Figure 5.64.

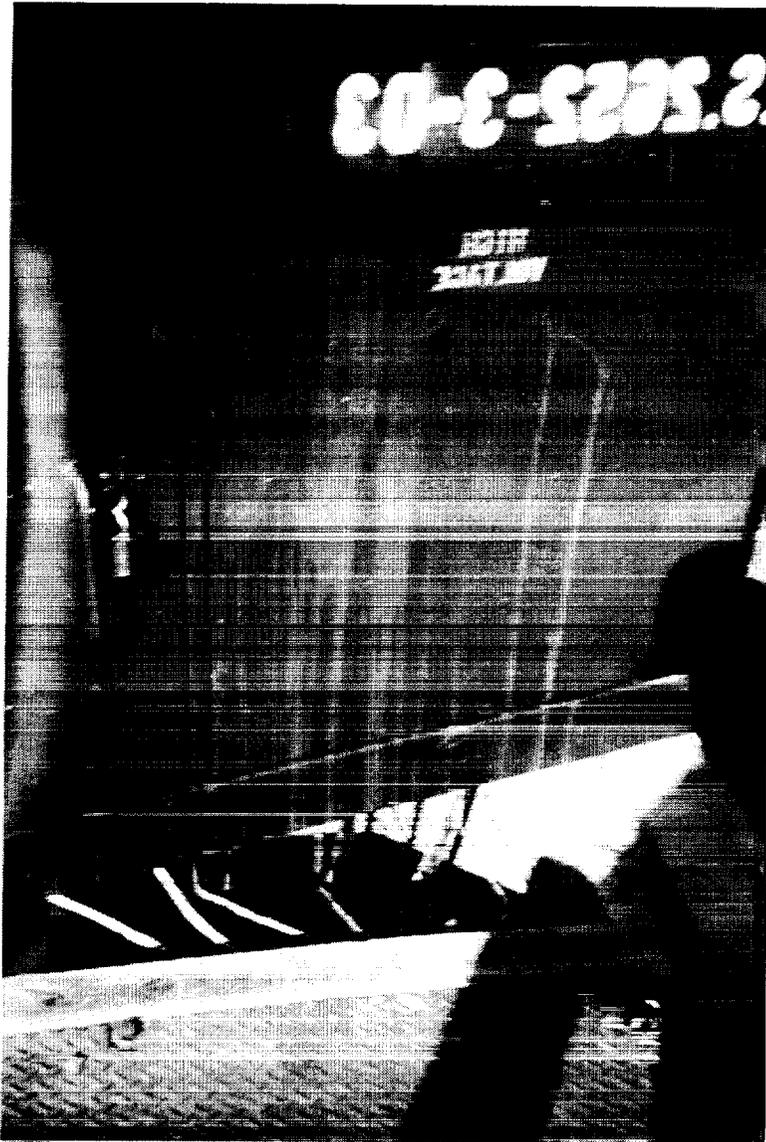
Figure 5.81 Slab-mounted distribution transformer was unanchored and slid on its slab.

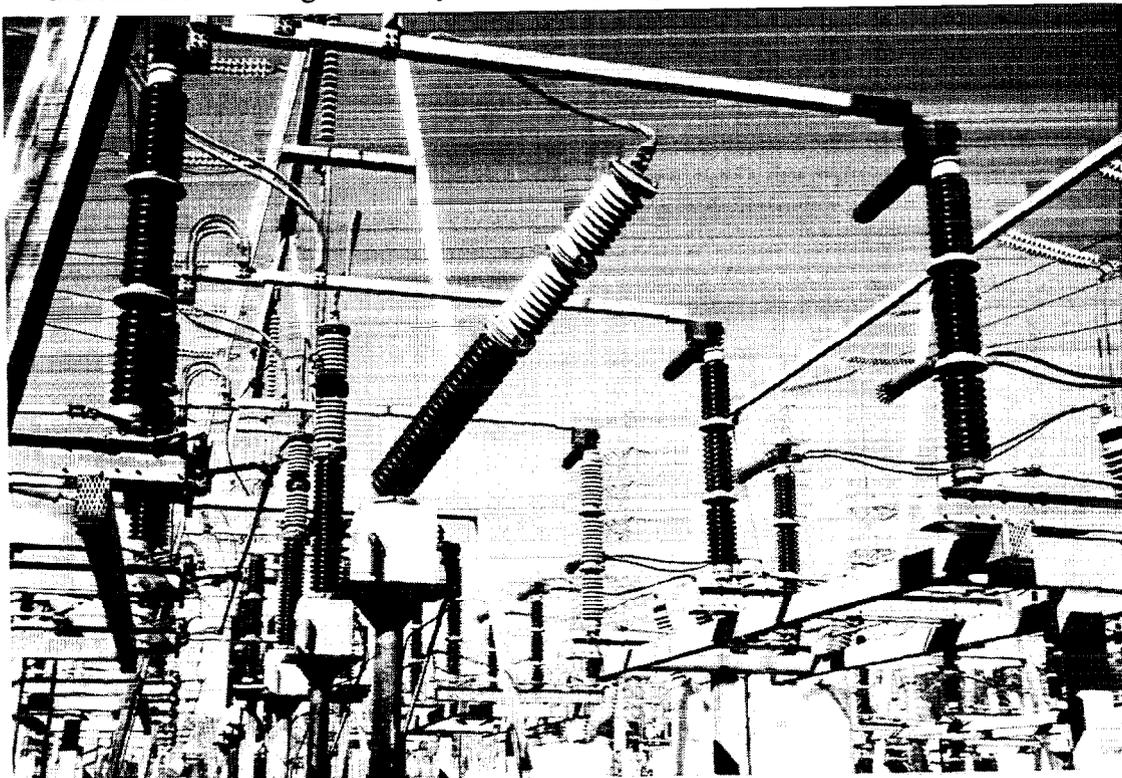
Figure 5.104 The IT in the foreground has failed. The configuration of the conductors seen in the background suggests that the failure was due to inertial loads.

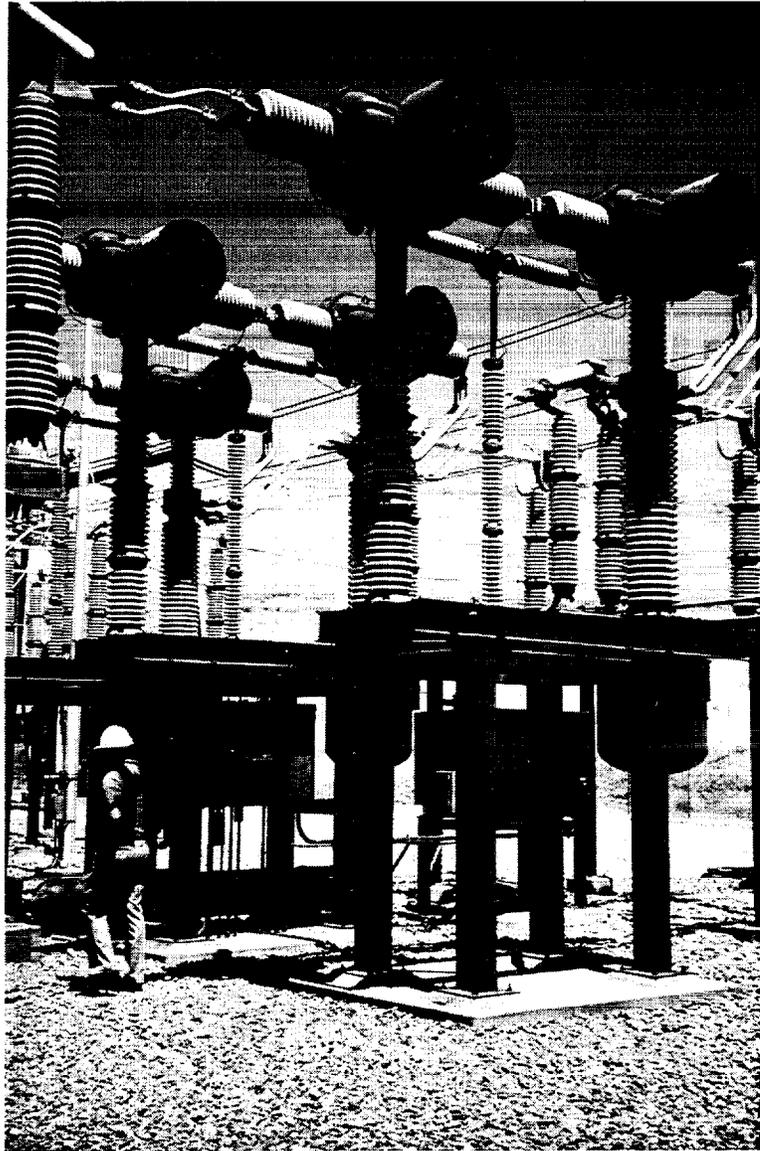
Figure 5.112 One of the more vulnerable models of live-tank circuit breaker. This site was designed for 0.5 g. It was constructed before the 1971 San Fernando earthquake and only circuit breakers "qualified" to 0.2 g static analysis were available at that time.

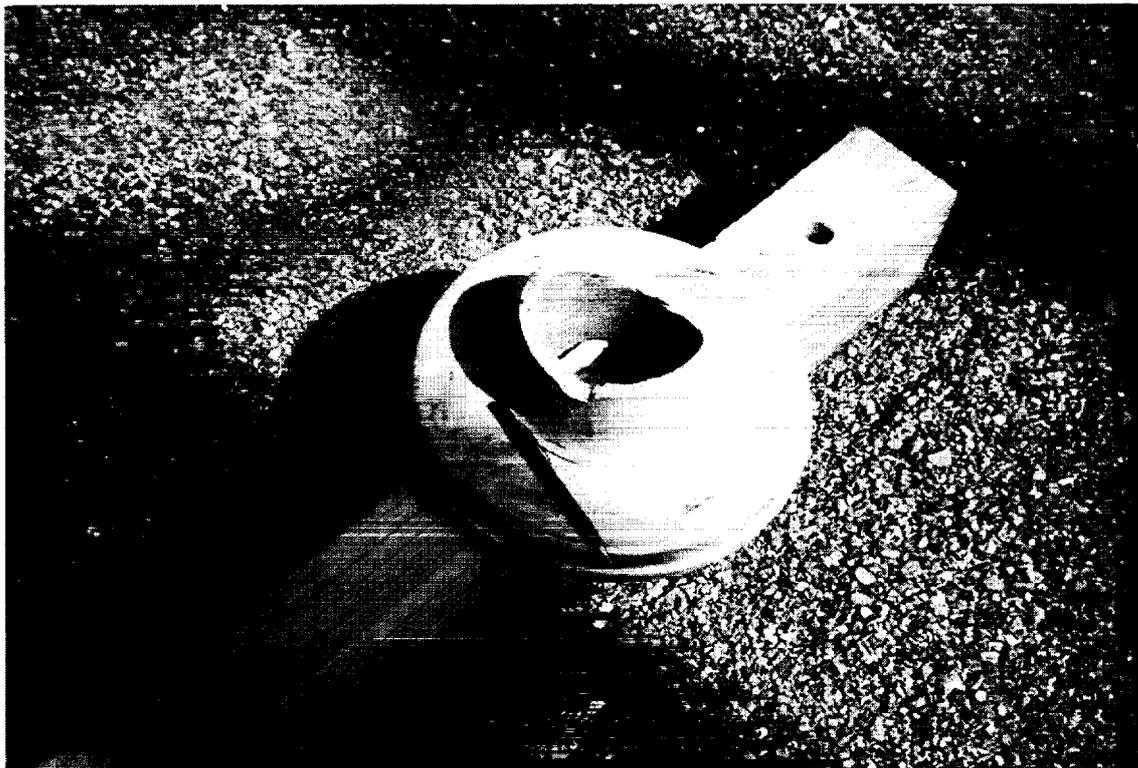
Figure 5.119 Aluminum casting supporting the interrupter head had a brittle fracture failure.

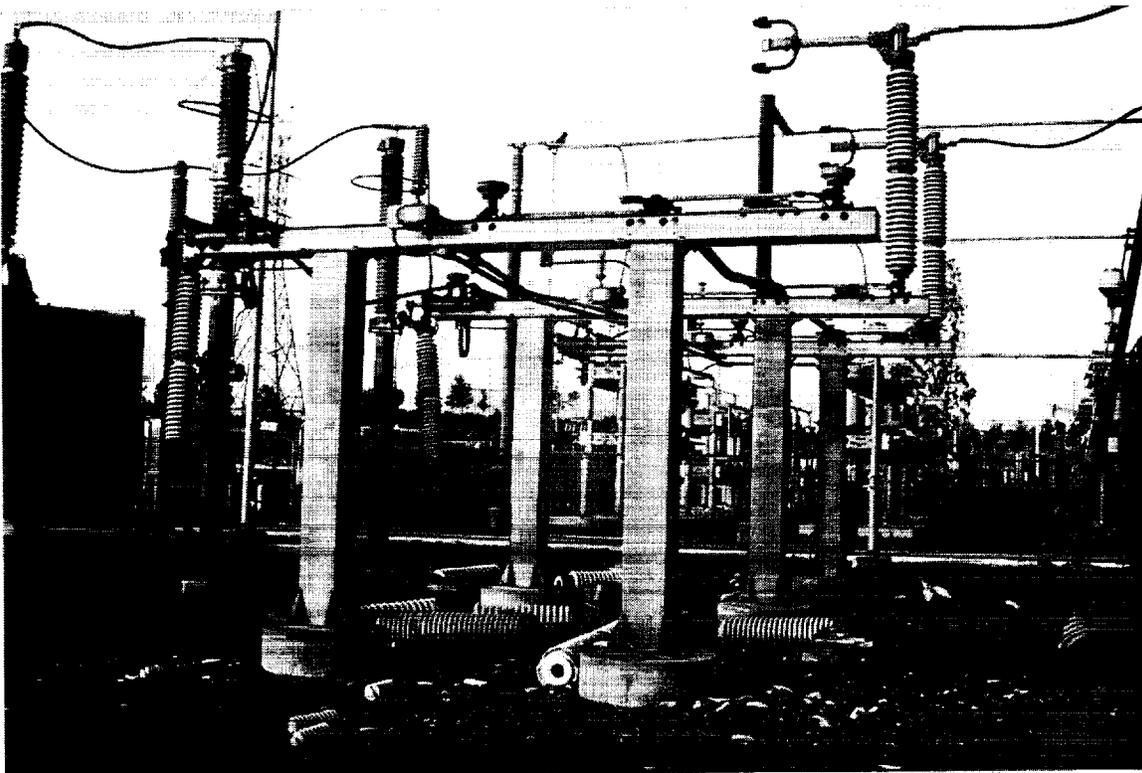
Figure 5.129 These damaged circuit switchers were purchased and installed at the same time as another identical group located about 180 m (600 feet) away. One set had minor damage while the other circuit switchers were severely damaged. This suggests large variations in ground motions within a site.

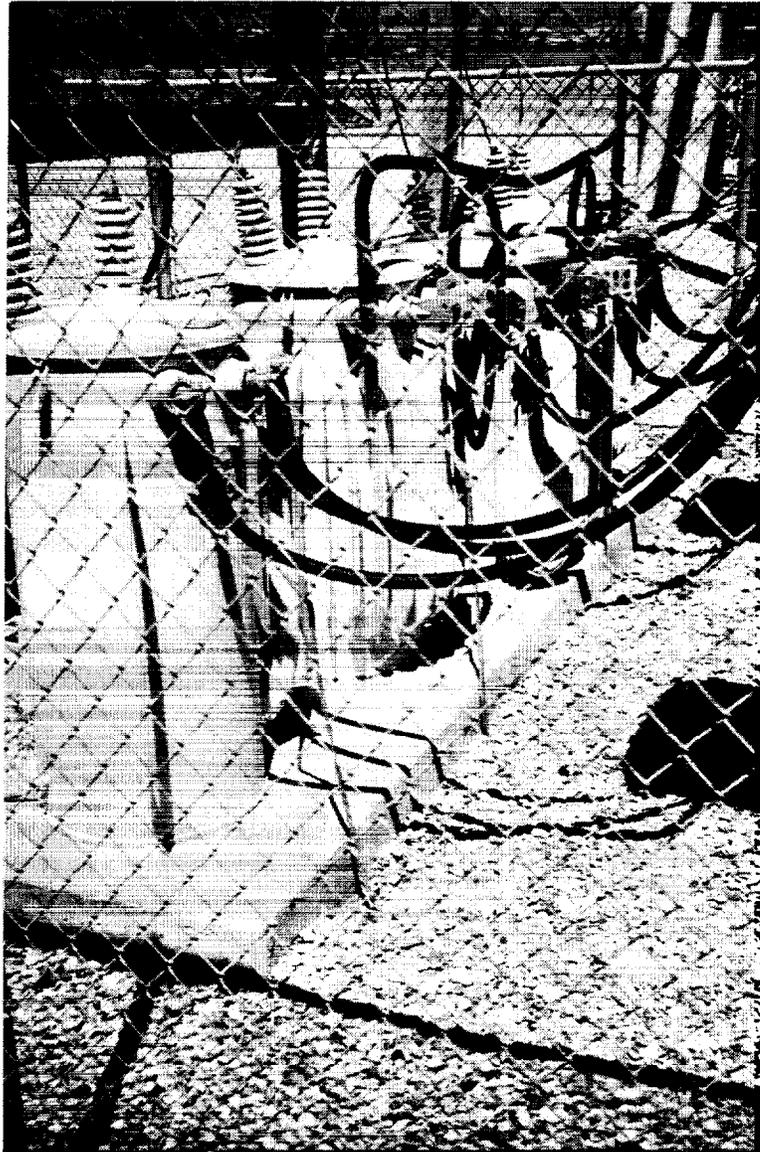
Figure 5.152 One of the most common methods of supporting the station transformers is by placing them on a concrete slab at grade without anchorage.

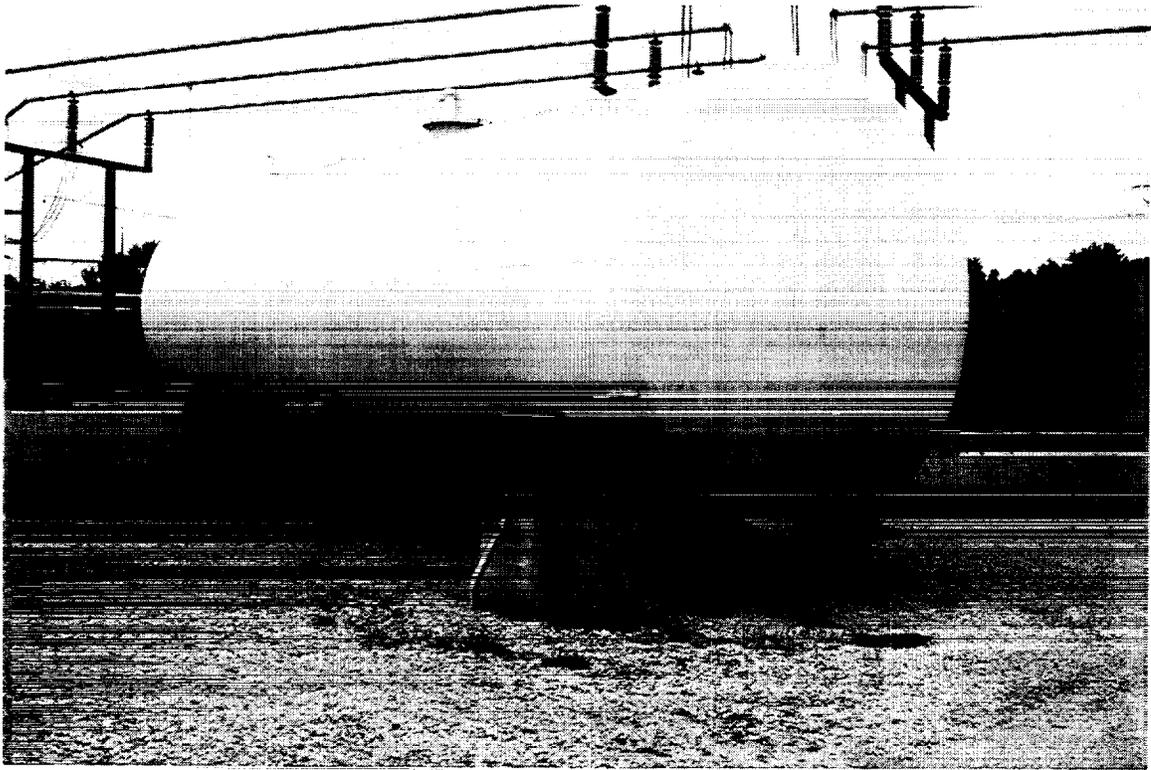
Figure 5.155 Horizontal tanks are frequently unsecured to their cradles.

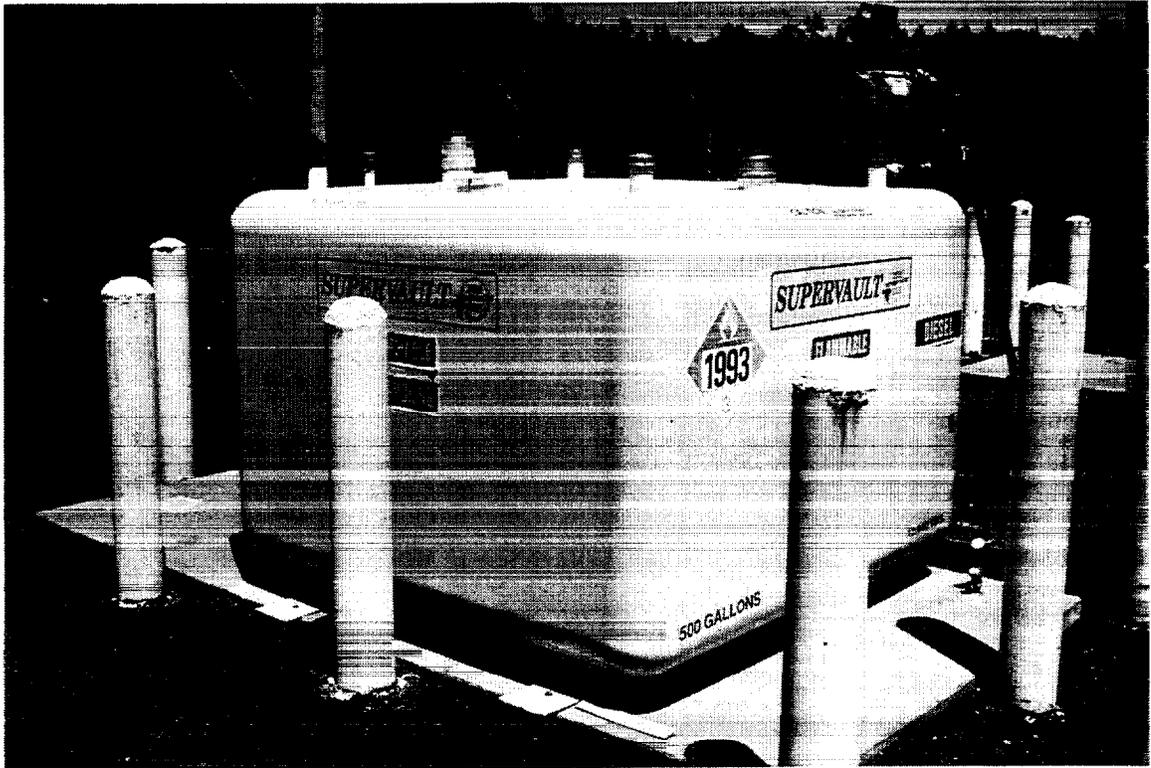
Figure 8.13 Typical fuel tank that replaces older buried tank.
