**NIST GCR 05-875**

# **Research Investigation for Determination of Residential Sprinkler Performance**

*RESEARCH INVESTIGATION  
FOR DETERMINATION OF RESIDENTIAL  
SPRINKLER PERFORMANCE*

*Prepared by  
Underwriters Laboratories Inc.  
Project 03NK26622, US354  
for*

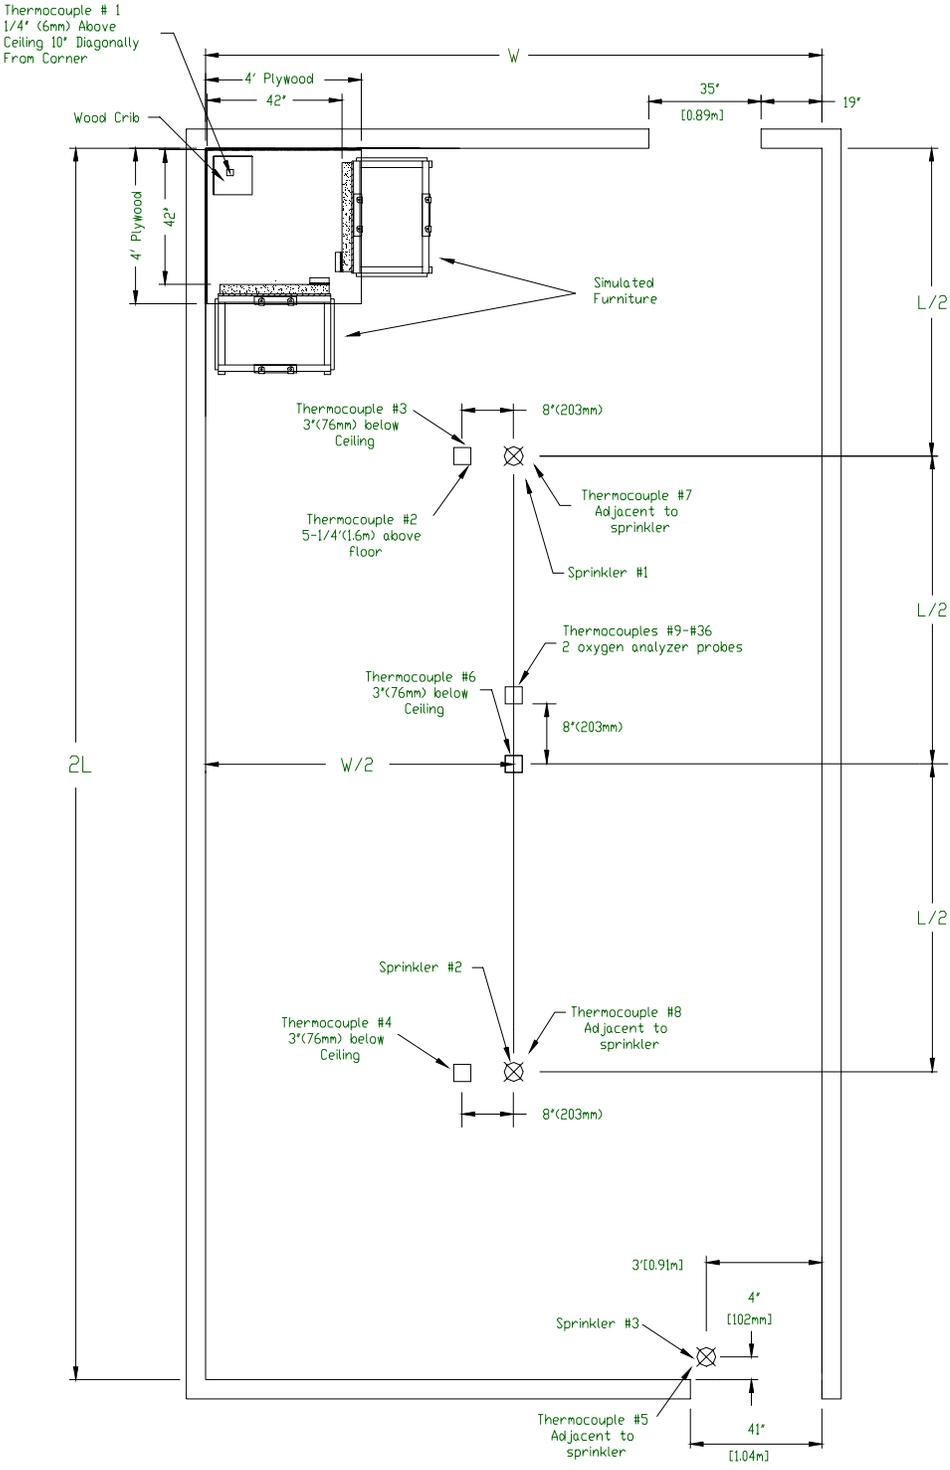
L= Coverage length  
W= Coverage width

Figure 2. Plan view of room for Test Nos. 1-12. Pendent and recessed pendent sprinklers with the fire source located in the corner.

The tests were conducted in a test room with an approximately 7 feet 11 inch (2.41 m) high ceiling, having nominal dimensions described in Figure 2 to Figure 7 as follows:

| Figure 2 | Pendent and recessed pendent sprinklers with fire source location in the corner. |

For each test, three sprinklers were installed as described in Table 2. The location of the sprinklers are described in Table 4 and illustrated in Figure 2 to Figure 7. The sprinkler near the doorway furthest from the fire source was installed with the heat responsive element 2 inches (51 mm) below the ceiling for pendent sprinklers and for sidewall sprinklers, the deflector was 4 inches (102 mm) below the ceiling.

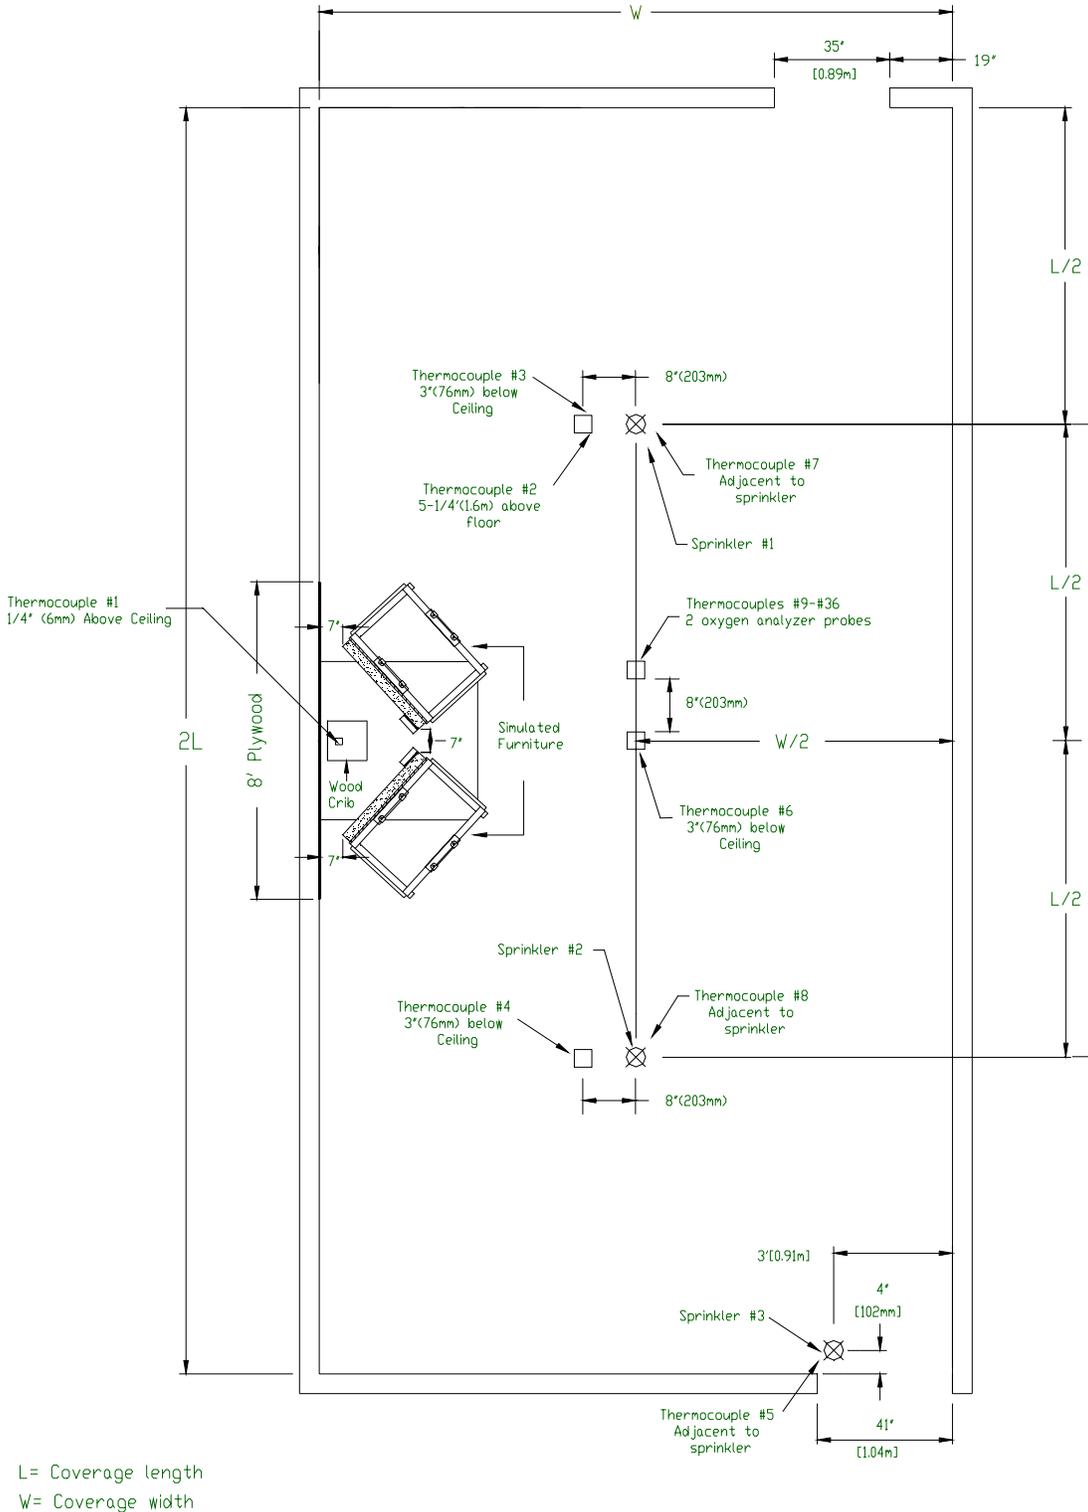
Figure 3. Plan view of room for Test Nos. 16 and 19-22. Pendent and recessed pendent sprinklers with the fire source located between two sprinklers.

| Figure 3 | Pendent and recessed pendent sprinklers with fire source location between two sprinklers. |

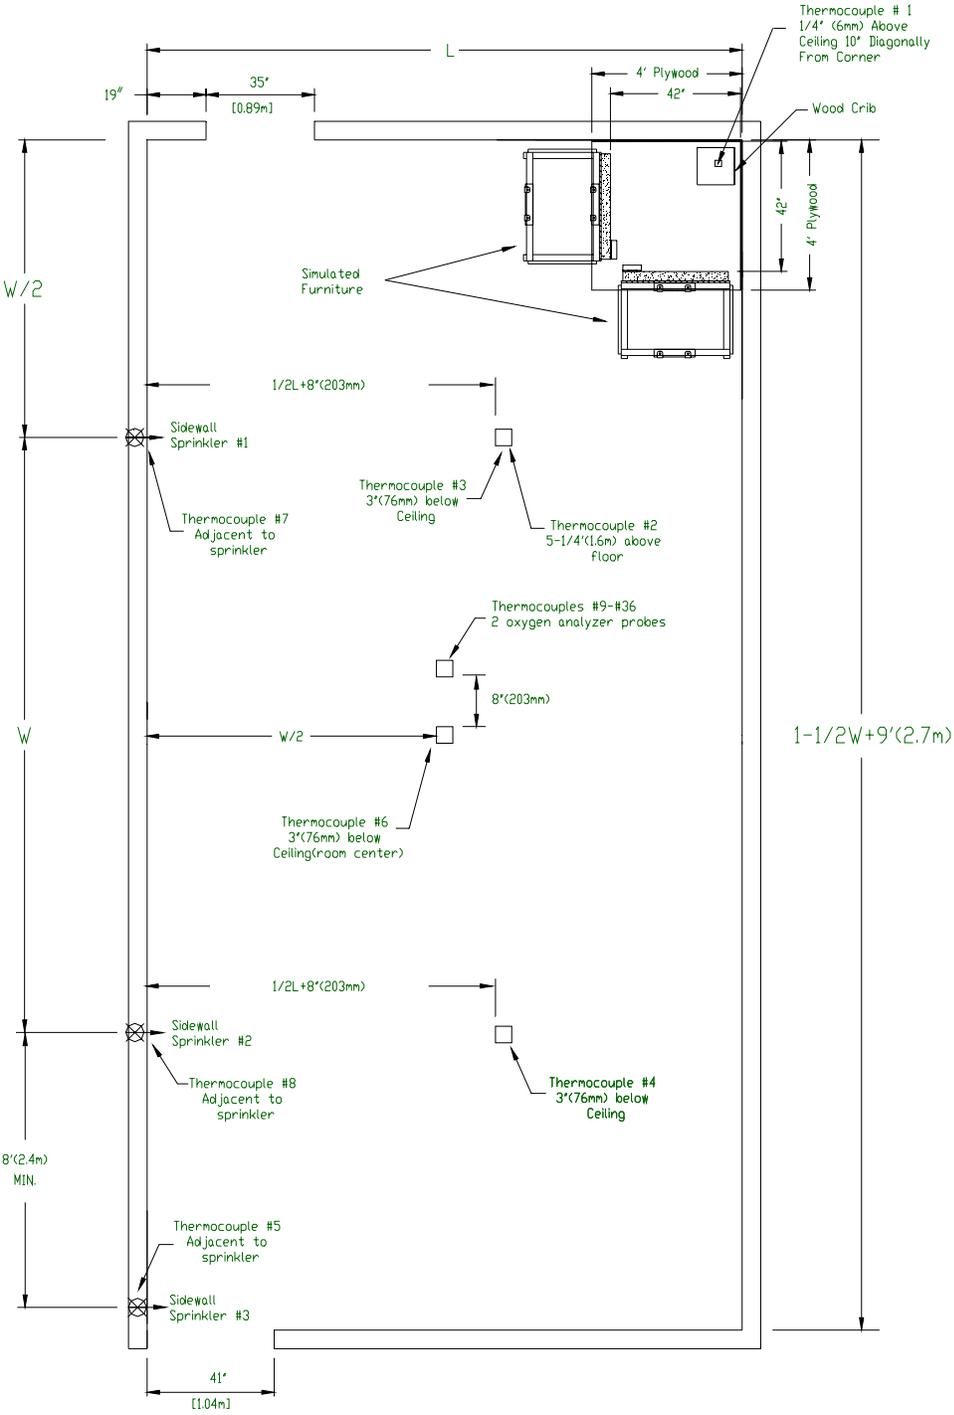
L= Coverage length  
 W= Coverage width

Figure 4. Plan view of room for Test Nos. 13 and 14. Horizontal sidewall sprinklers positioned on far wall with the fire source located in the corner.

| Figure 4 | Horizontal sidewall sprinklers positioned on far wall with fire source location in corner. |

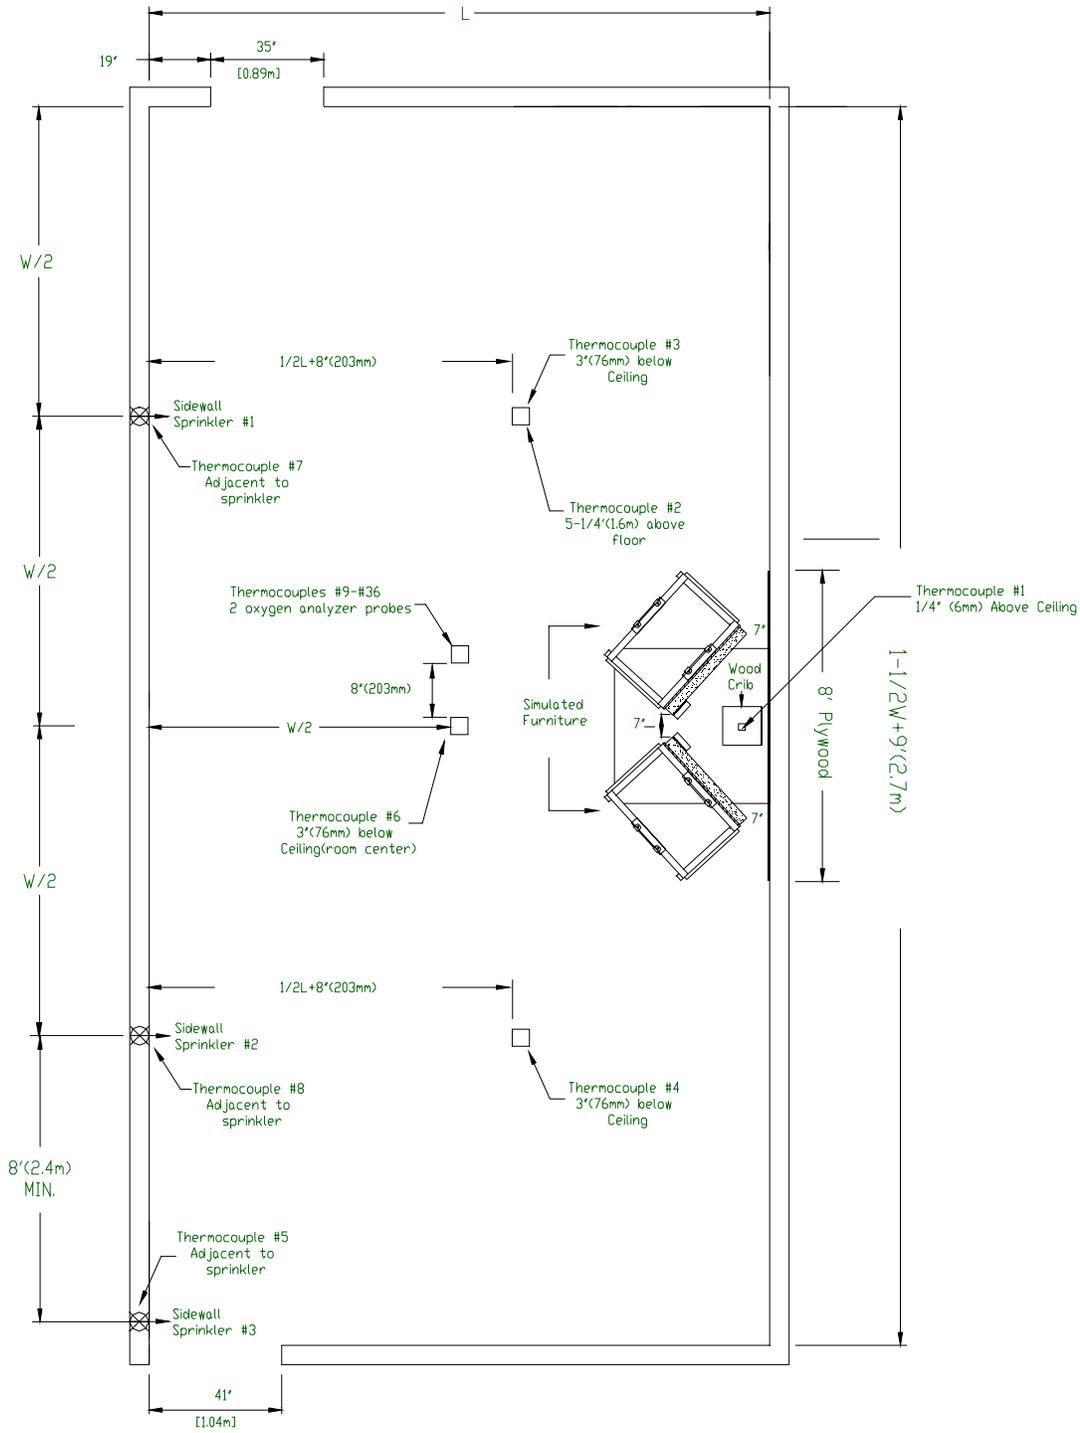
L= Coverage length  
W= Coverage width

Figure 5. Plan view of room for Test No. 17. Horizontal sidewall sprinklers positioned on far wall with the fire source located between two sprinklers.

| Figure 5 | Horizontal sidewall sprinklers positioned on far wall with fire source location between two sprinklers. |

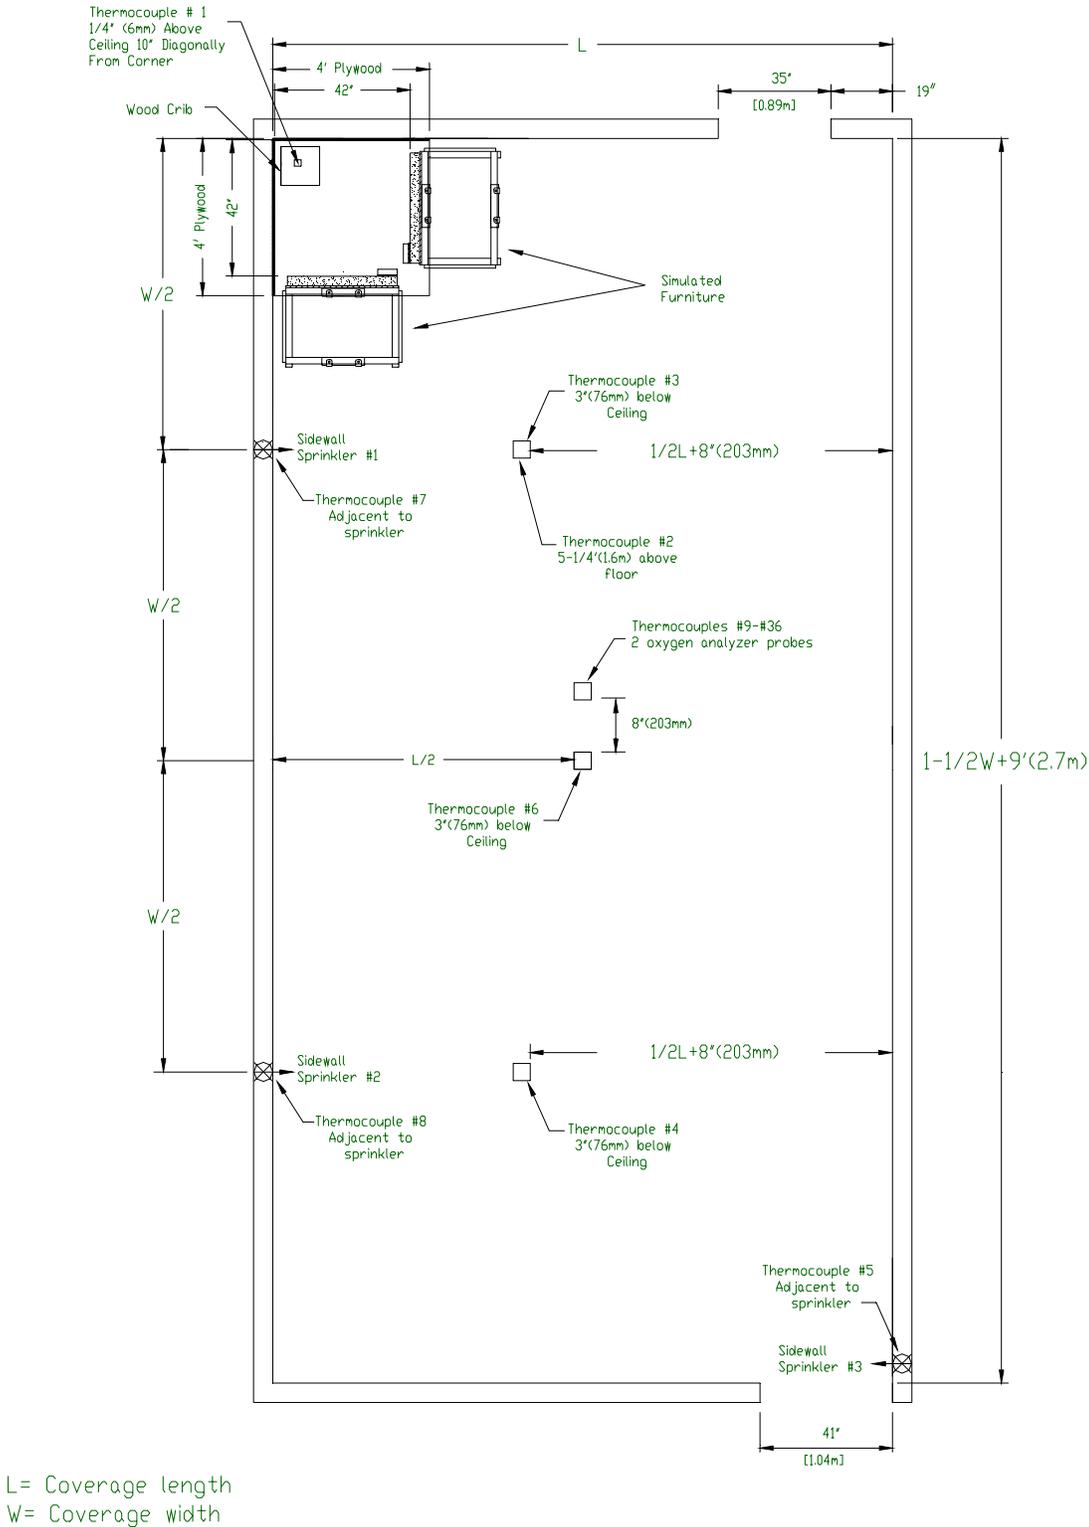
Figure 6. Plan view of room for Test No. 15. Horizontal sidewall sprinklers positioned on near wall with the fire source located in the corner.

| Figure 6 | Horizontal sidewall sprinklers positioned on near wall with fire source location in corner. |

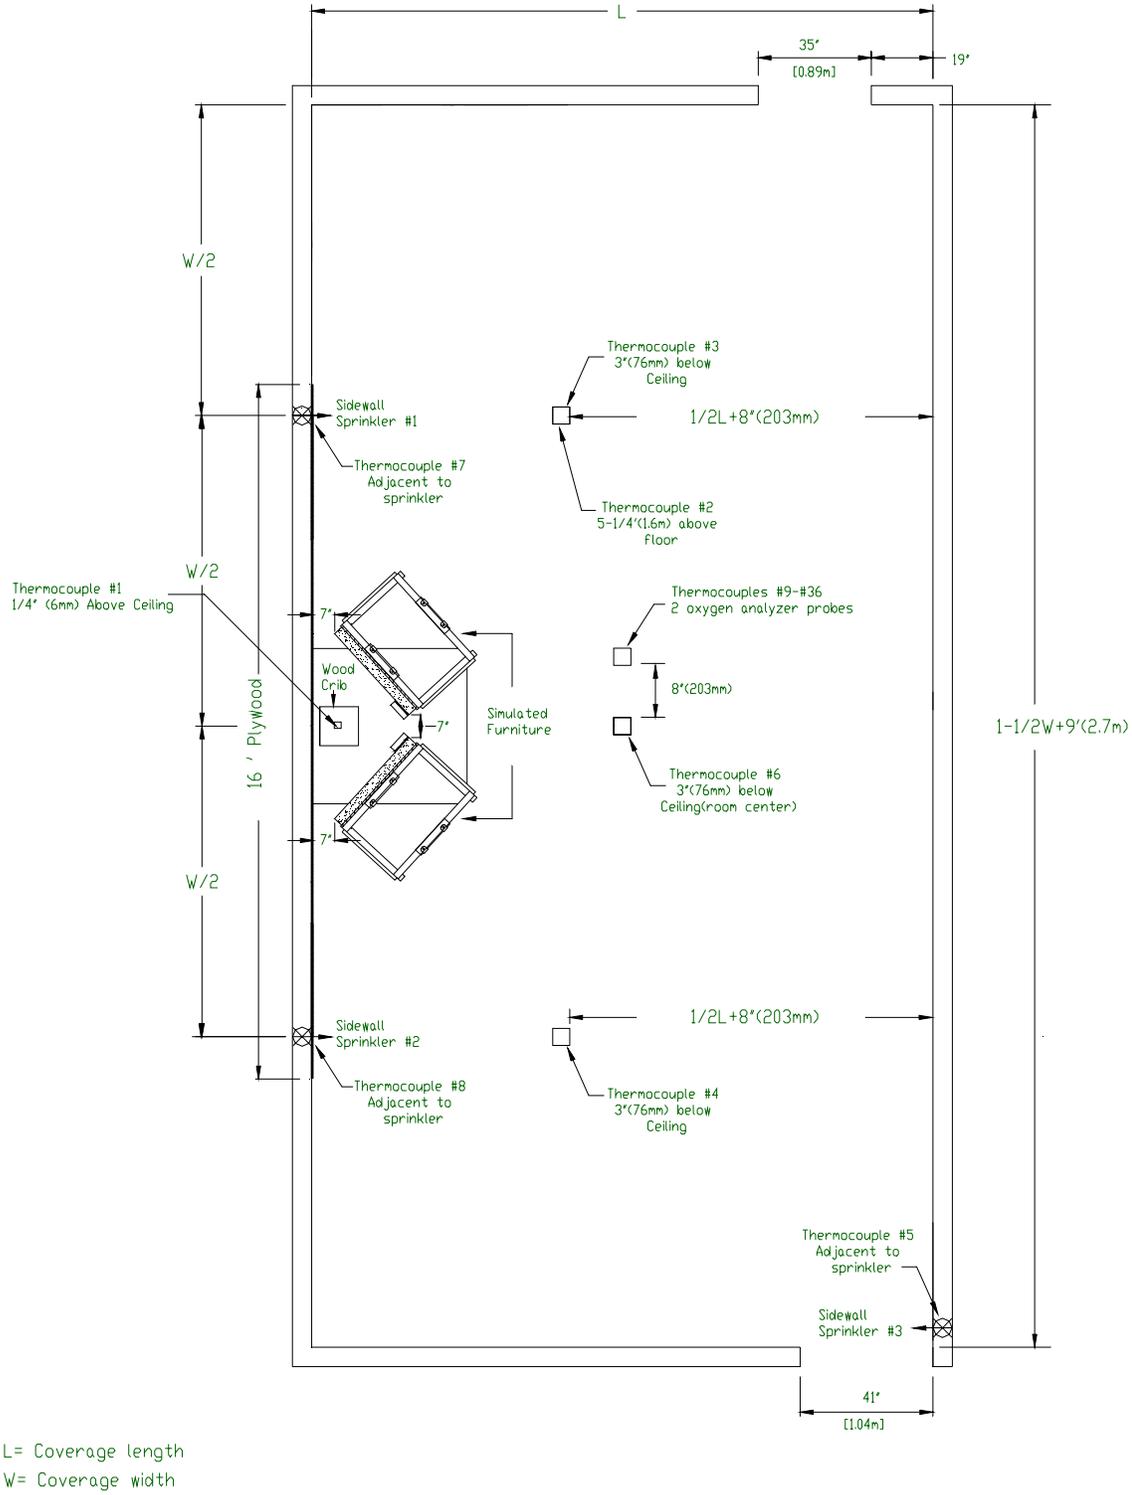
Figure 7. Plan view of room for Test No. 18. Horizontal sidewall sprinklers positioned on near wall with the fire source located between two sprinklers.

| Figure 7 | Horizontal sidewall sprinklers positioned on near wall with fire source location between two sprinklers. |
