The January 17, 1994, Northridge Earthquake, California

H. S. Lew¹, Jim Cooper², Sam Hacopian³, Walter Hays⁴, and Mike Mahoney⁵

ABSTRACT

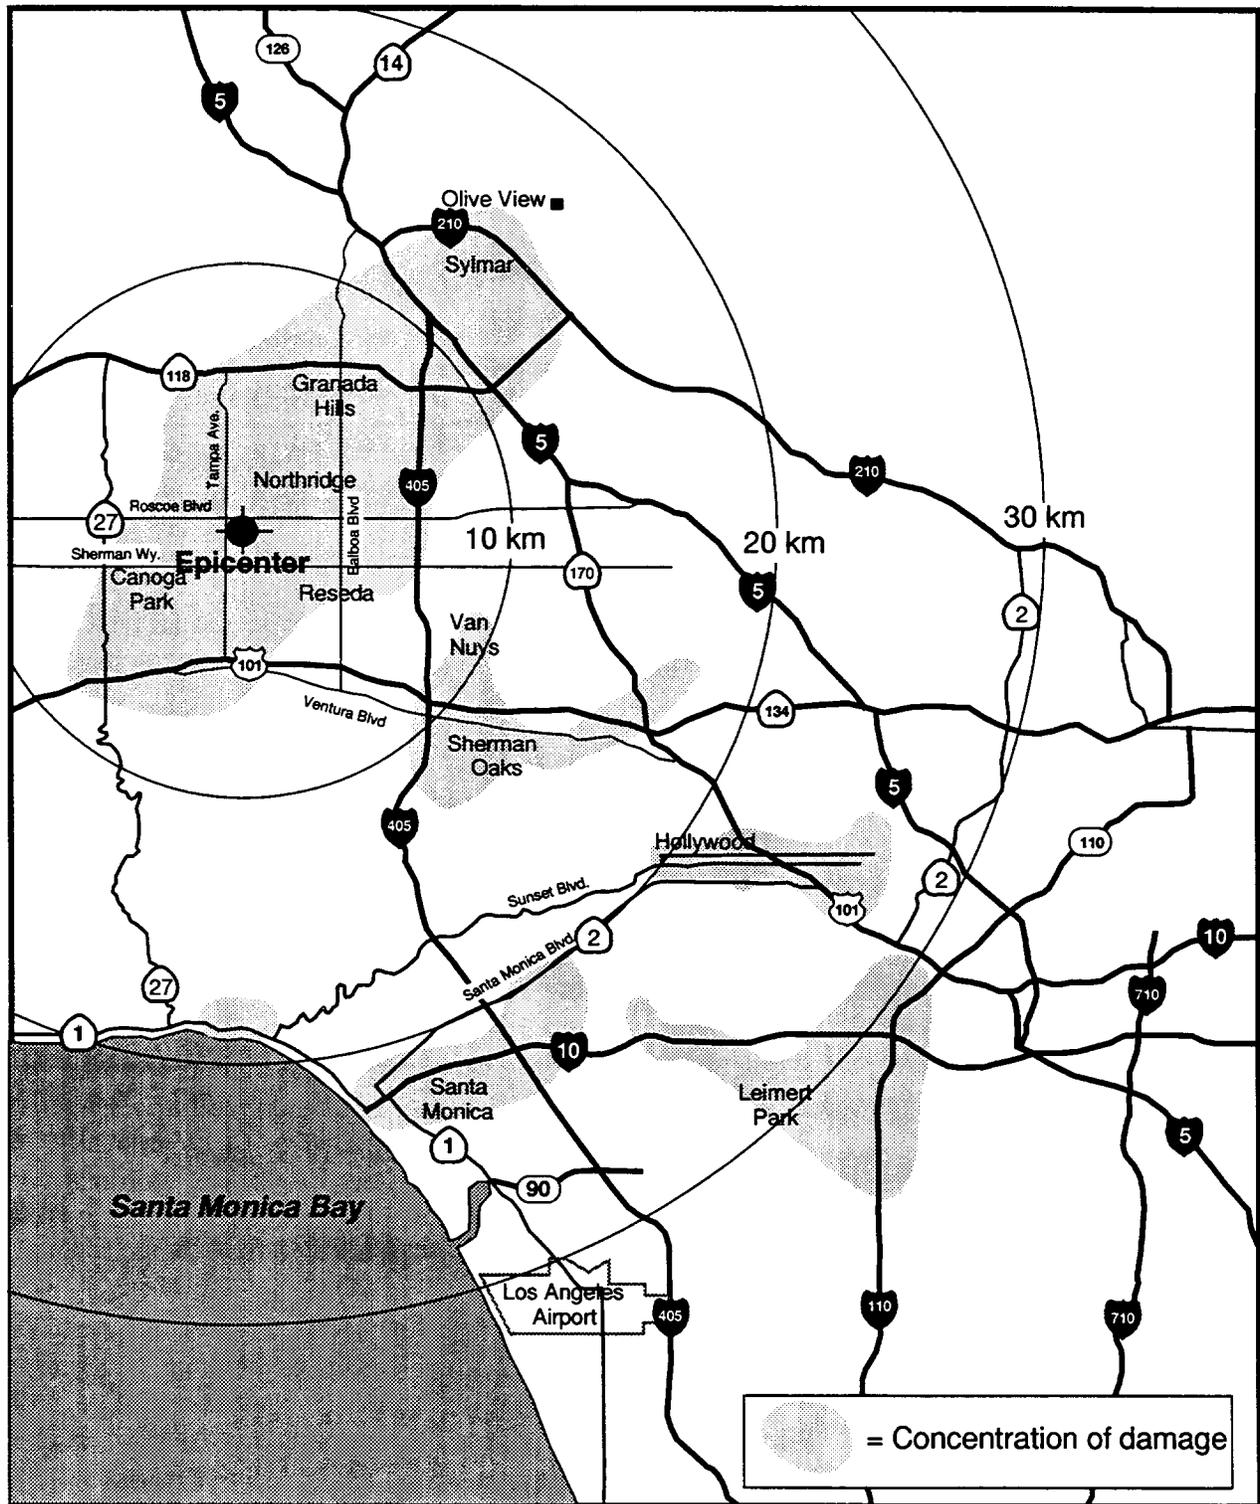
Figure 4 Serious damage to buildings caused by the magnitude 6.8 Northridge earthquake was widespread, but, outside of the epicentral area, seriously damaged buildings tended to occur in pockets.

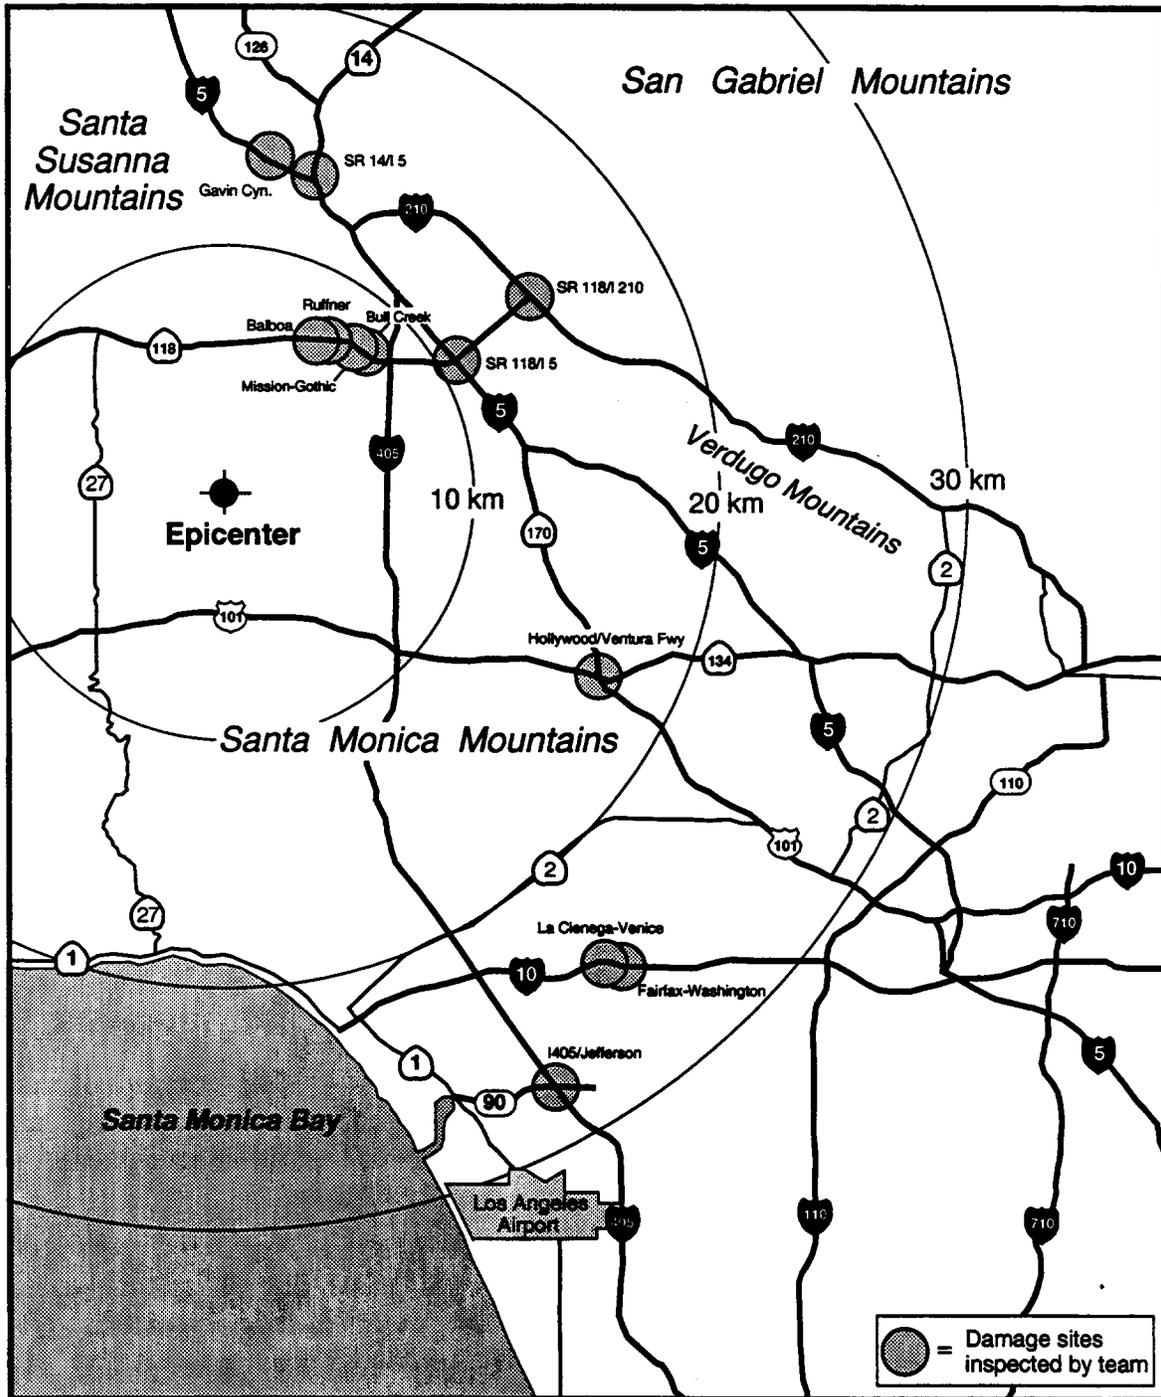
Figure 23 Bridge damage sites studied by the reconnaissance team

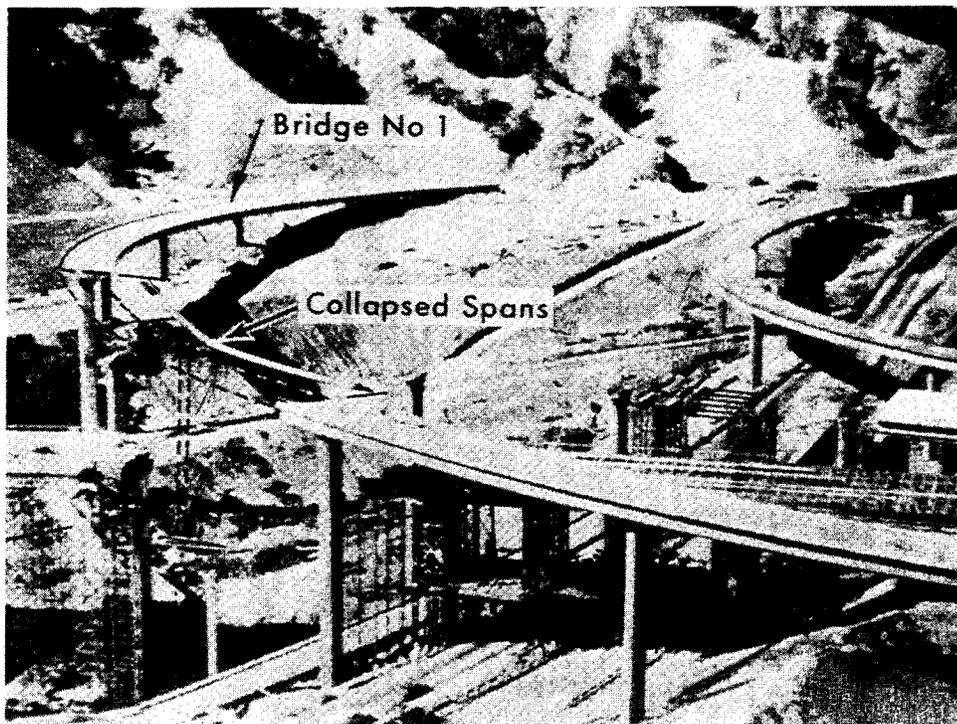
This interchange was designed in 1968 and was under construction in 1971 when portions were damaged by the San Fernando earthquake. At that time, one of the completed ramps in the interchange collapsed, and two ramps which were under construction were damaged. The portion which collapsed in 1971 was the South Connector Overcrossing, connecting southbound I5 with eastbound SR14. A photograph of the collapsed ramp, taken in 1971, is shown in Figure 27. This ramp was later rebuilt, with improved pier reinforcement, and it suffered no significant damage in the Northridge earthquake. The damaged portions of the other two ramps under construction in 1971 were repaired in place, but not strengthened; the portions not yet constructed were completed with limited seismic upgrading. Both of the ramps which partially collapsed in the Northridge earthquake were under construction at the time of the 1971 earthquake.

Figure 27 SR14/I5 interchange after the 1971 San Fernando earthquake. View looking to the west, showing collapsed South Connector Overcrossing

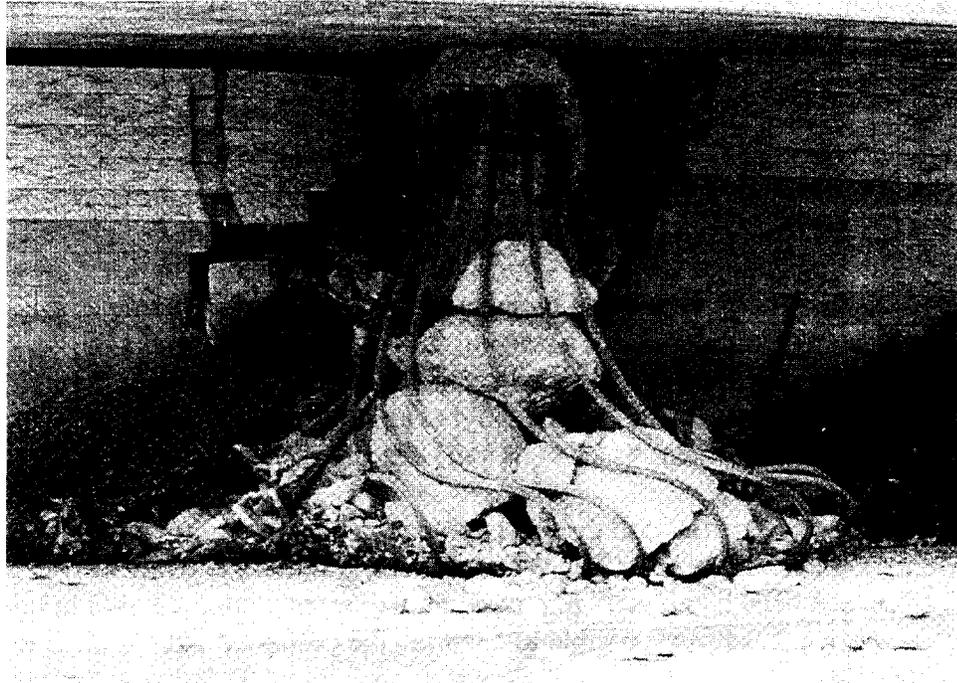
Figure 39 shows the northernmost pier of Bent 6, located just to the west of the hinge. This pier totally disintegrated, but the storage building prevented the roadway from collapsing to the ground. Figure 40 shows the southernmost pier supporting the

Figure 39 Northernmost pier of Bent 6 supporting westbound lane of I10 (west of Venice Blvd.)

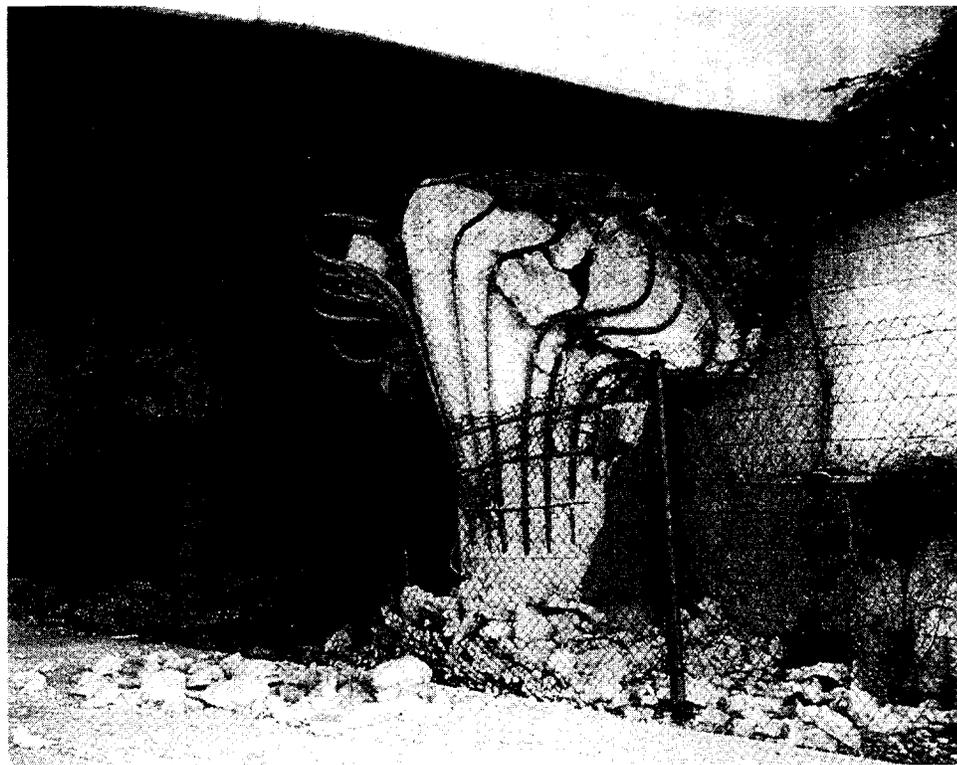
Figure 40 Piers of Bent 3 supporting eastbound lane of I10 at La Cienega Blvd.

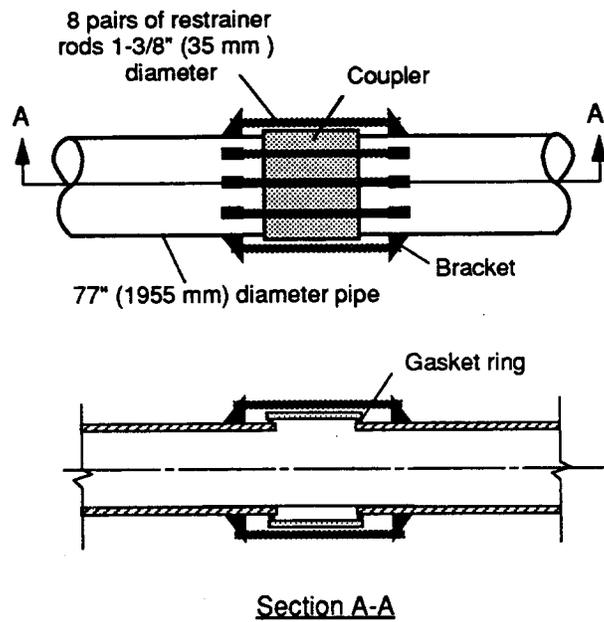
A steel pipe brings water up from the canyon below (Figure 44). The pipe is supported on concrete saddles built along the mountain slope. In a few places, the pipe separated from the saddles creating 50 to 80 mm gaps. In at least one location, the pipe crashed into the saddle. In two other locations, the pipe sections bulged 80 mm and 150 mm respectively. However, no rupture or leakage was noticed. The ruptured section of the 2.1-m pipe is located near top of the hill. The two sections where the rupture occurred were connected together using a mechanical coupling system (Figure 45). To restrain the relative movement between the two pipe sections during strong shaking, the sections were connected by eight pairs of restrainer rods 35 mm in diameter and 2.2 m long. The rods were attached to brackets, which were welded to the pipes. These welds broke due to strong shaking and resulted in the separation of the two pipe sections.

Figure 45 Schematic drawing of connection of the two steel pipe sections which were pulled apart during the earthquake.

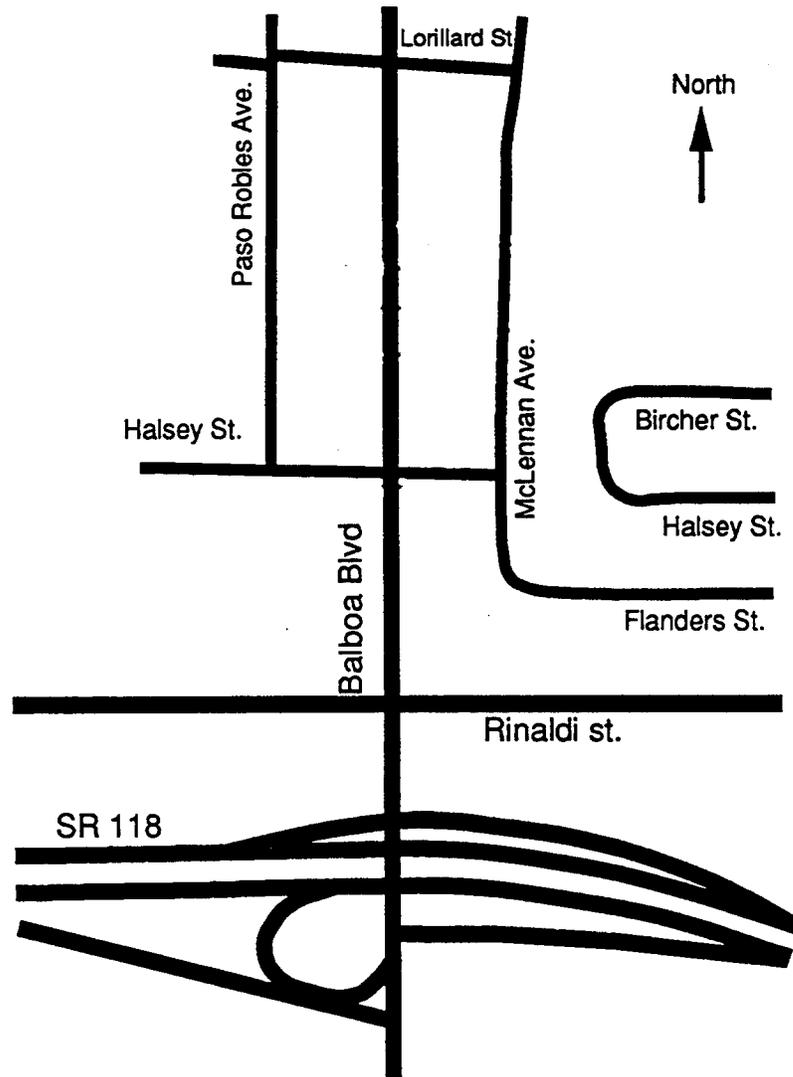
The rupture of a 0.6-m gas main occurred along Balboa Boulevard between Rinaldi Street to the south and Lorillard Street to the north, about 0.5 km north of the intersection of Balboa Boulevard and SR118 (Figure 46). Along this stretch, compressional ground failures occurred between Rinaldi Street and Halsey Street, and extensional ground failures occurred between Bircher Street and Halsey Street.

Figure 46 Location of the 0.6-m gas main rupture on Balboa Boulevard.

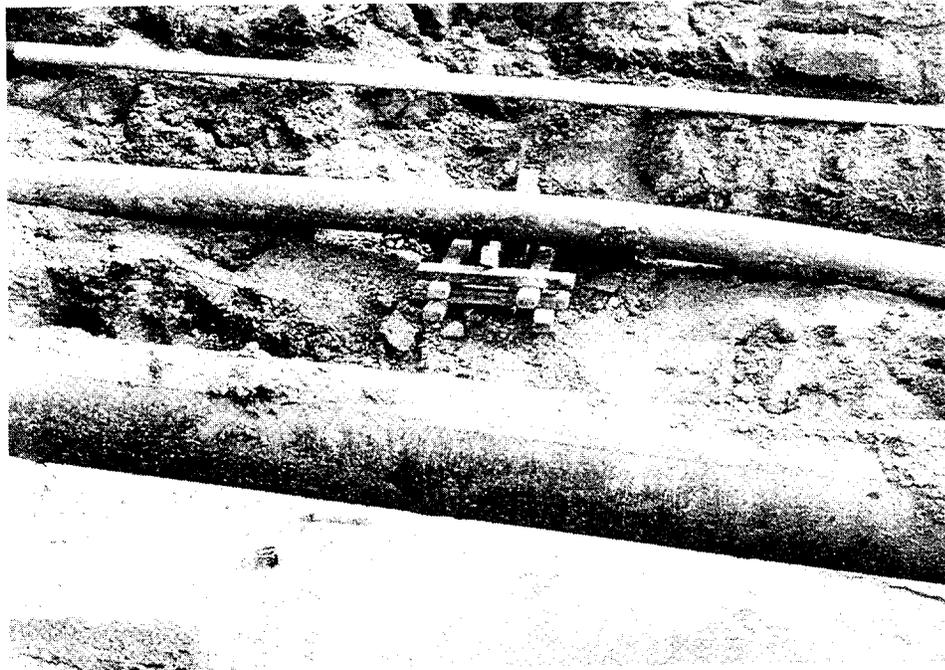
An excavated section just north of the fire site revealed some additional underground lines (Figure 50). The 460-mm crude oil line in the middle of the photo performed well. The 150-mm gas distribution line shown is a replaced section.

Figure 50 Some of the buried pipelines located near the intersection of Balboa Boulevard and Bircher Street--the potential hazard of co-location of lifeline systems. At this site are three water lines (two of them main lines); three gas lines; two sewers; one crude oil line; overhead power, telephone, and cable TV lines; the street lighting system; and the street itself.

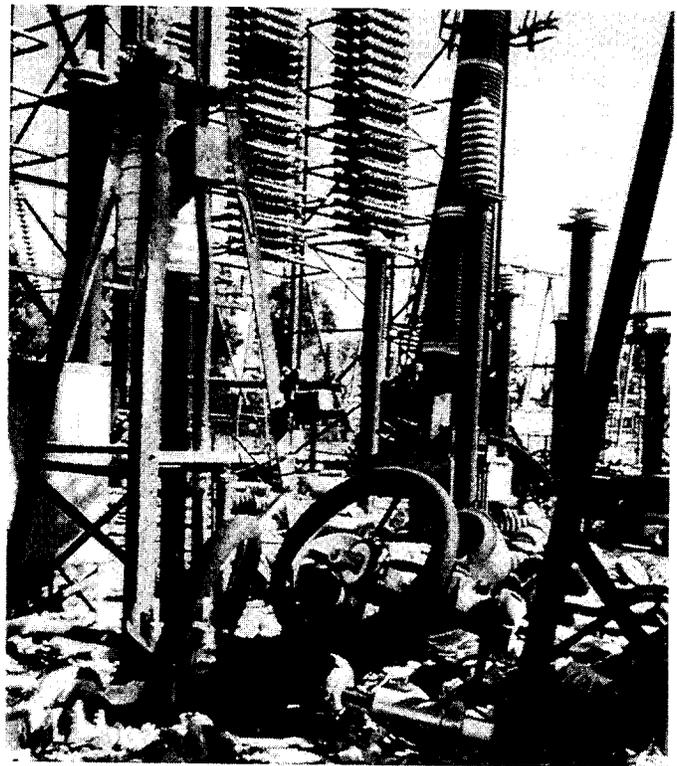
Figure 52 Porcelain is an integral part of high voltage electrical equipment due to insulation requirements and is also the most vulnerable to damage during strong earthquake shaking. (Photo courtesy of Edward Matsuda, Pacific Gas and Electric Company.)

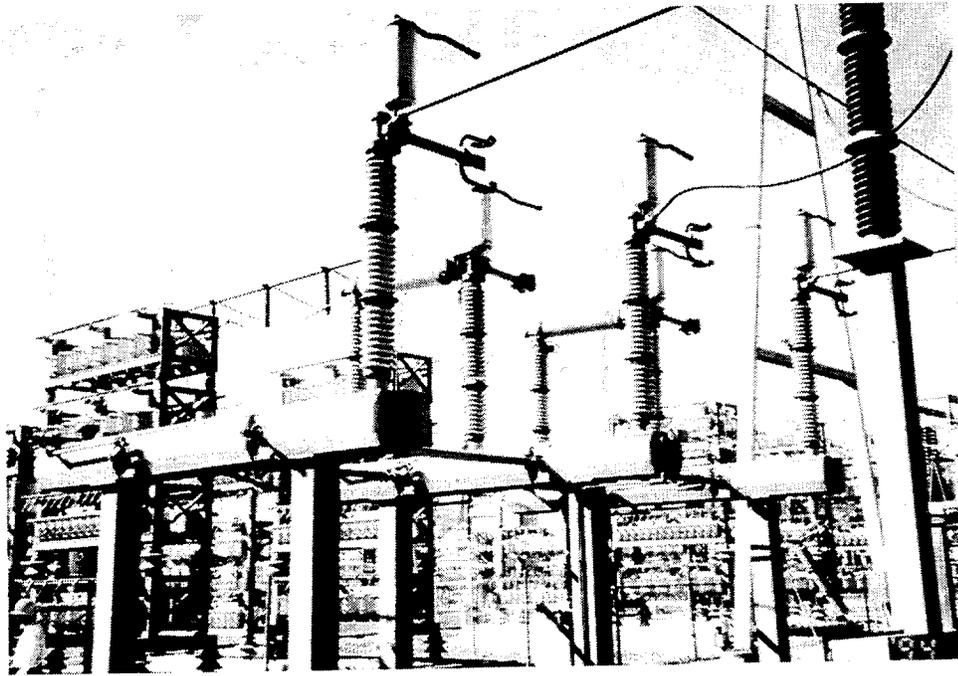
Figure 53 Most of the 230 kV circuit switchers (in the forefront) at the Sylmar substation were damaged. Most of the capacitor banks (in the background) performed well in this earthquake, whereas most collapsed during the 1971 quake. (Photo courtesy to Edward Matsuda of Pacific Gas and Electric Company.)

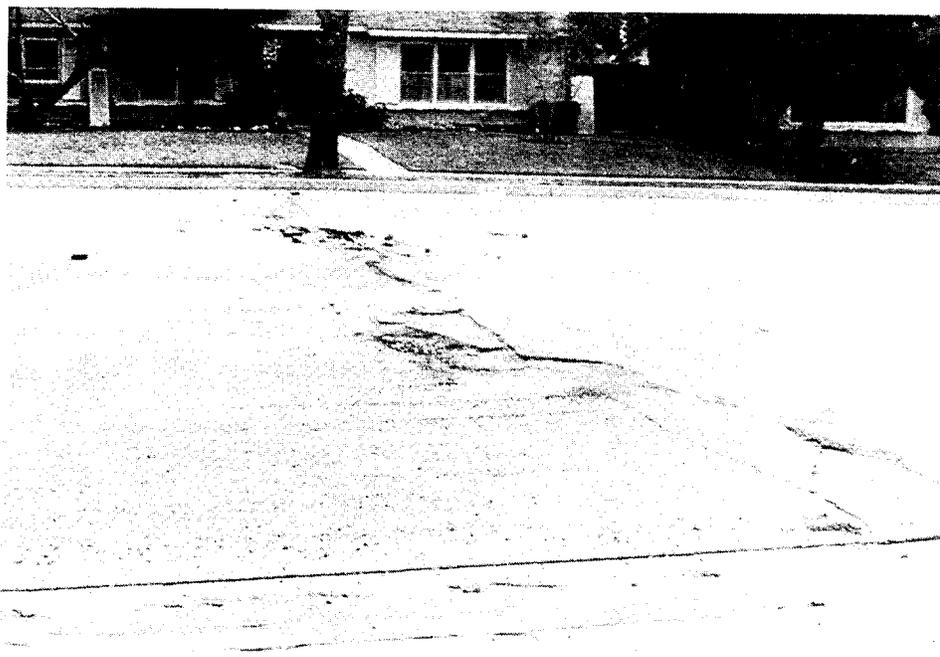
Strong ground shaking and lateral movement of subgrade materials resulted in numerous ruptures of asphalt pavement and concrete sidewalks in the epicentral area (Figure 55). In some instances, local traffic was interrupted temporarily waiting for the repair of these cracks. In most cases, the damage was minor and local traffic was not interrupted. The south approach of Balboa Boulevard at SR118 caved in from loss of abutment fill due to a water main break. This bridge was closed for traffic due to some structural damage to the piers and the loss of the south abutment fill.

Figure 55
Transverse cracks
in pavement along
Balboa Boulevard
in Northridge area.
